# Access Compliance Report

## Public Rights-of-Way

| Intersection ID: 49656 | Main Street: SKYLINE_VIEW_WY | Cross Street: SEIGLE_POINT_DR | Location: | N |
| ADA ID: D92FCF2476EC | Ramp Type: Perp | Initial Pass/Fail: Pass | Overall Compliance: No | Severity Score: 0.25 |

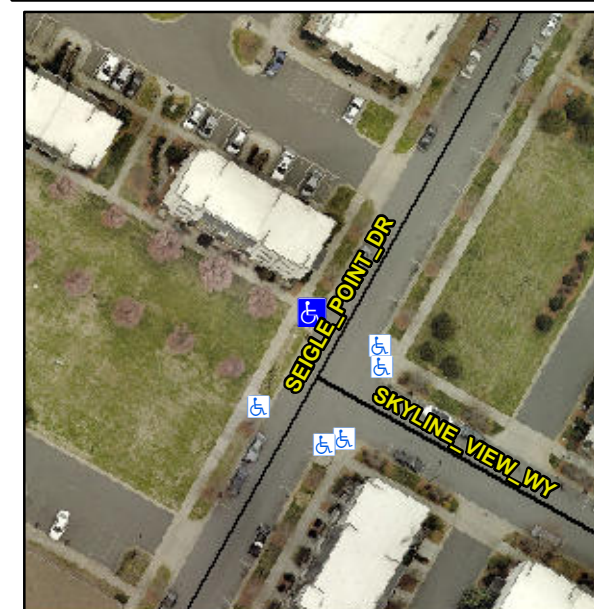
**Not Found, R304.5.3**

| Compliance | Description | Data | Compliance | Description | Data |
|---|---|---|---|---|---|
| Yes | Ramp Width (in) | 74.0 | No | Ramp XSlope (%) | 2.8 |
| No | Landing X Slope (%) | 2.8 | Yes | DWS Full Width? | Yes |
| Yes | Gutter Lip Ht (in) | 0.0 | No | Gutter X Slope (%) | 3.3 |

Possible Solutions:

**Remove & Replace Entire Ramp.  
Remove & Replace Gutter.**

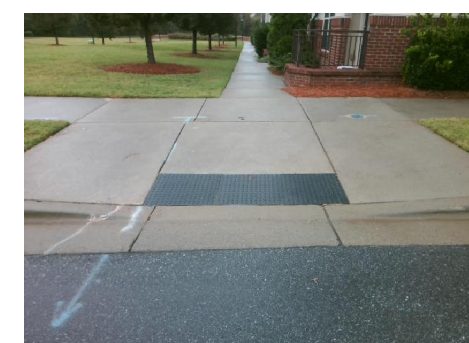
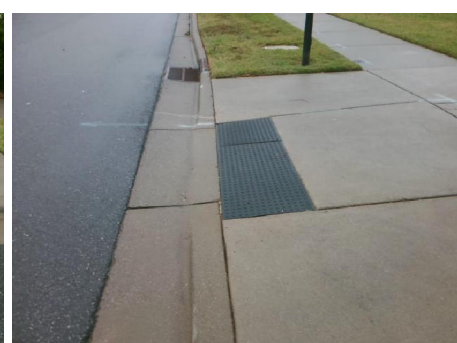
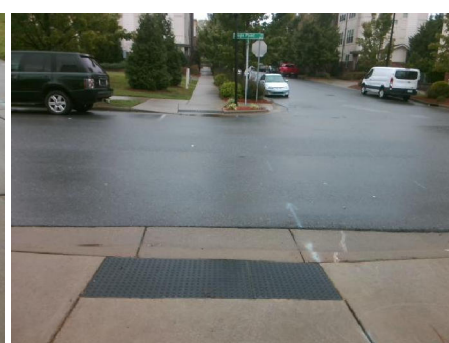
| Compliance | Description | Data | Compliance | Description | Data |
|---|---|---|---|---|---|
| | | | Yes | Surface Condition? (G/P) | Good |
