# Access Compliance Report

## Public Rights-of-Way

### (Curb Ramps)

Intersection ID: 10026804	Main Street: FOREST_POINT_CR	Cross Street: N/A	Location: NW
ADA ID: D9396C7445A0	Ramp Type: BlendTrans2	Initial Pass/Fail: Fail	Overall Compliance: No
Severity Score: 8.75			
Codes/Mitigation Info/Possible Solution		Field Measurements/Component Compliance

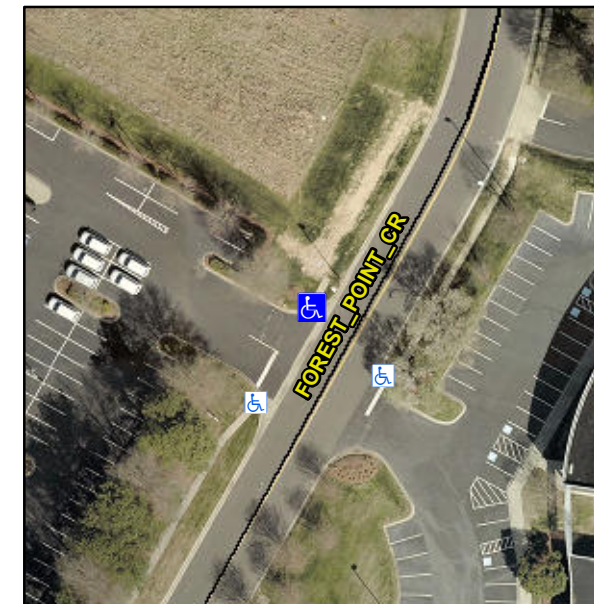
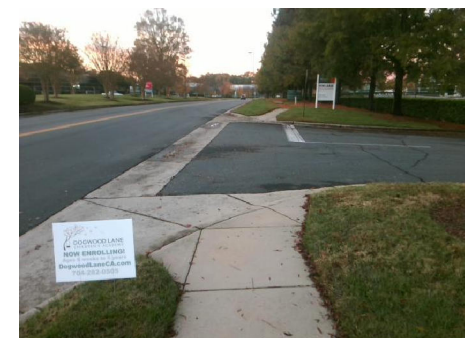
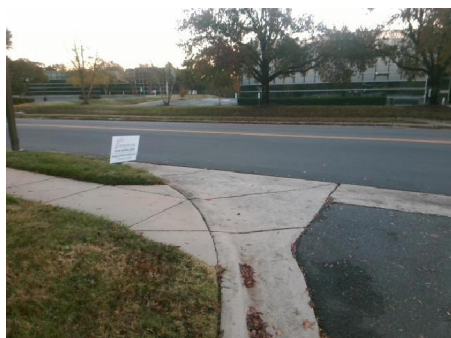
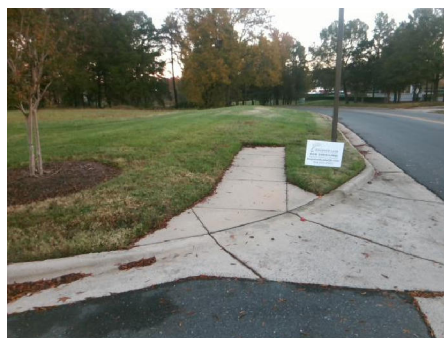
**Not Found, R304.5.1**

Compliance	Description	Data	Compliance	Description	Data
N/A	Ramp Length (in)	37.0	Yes	BlendTrans Slope (%)	4.6
No	Ramp Width (in)	40.0	Yes	BlendTrans XSlope (%)	1.0
N/A	Flare Type LT	N/A	N/A	Flare Type RT	N/A
N/A	Flare Slope LT (%)	N/A	N/A	Flare Slope RT (%)	N/A
N/A	Flare Traversable LT?	N/A	N/A	Flare Traversable RT?	N/A
N/A	Landing Length (in)	N/A	N/A	DWS Provided?	N/A
N/A	Landing Width (in)	N/A	N/A	DWS Contrast?	N/A
N/A	Landing Slope (%)	N/A	N/A	DWS Length (in)	N/A
N/A	Landing X Slope (%)	N/A	N/A	DWS Full Width?	N/A
N/A	Landing Curb? (Y/N)	N/A	N/A	DWS Offset (in)	N/A
N/A	Shared Landing?	N/A			
N/A	Gutter Ponding?	N/A	N/A	Gutter Slope (%)	N/A
N/A	Gutter Lip Ht (in)	N/A	N/A	Gutter X Slope (%)	N/A
N/A	Painted X Walk1?	No	N/A	Painted X Walk2?	No
	X Walk 1 Direction	To SW		X Walk 2 Direction	To SE
	X Walk 1 Width (in)	N/A		X Walk 2 Width (in)	N/A
	X Walk 1 Slope (%)	1.9		X Walk 2 Slope (%)	5.1
	X Walk 1 X Slope (%)	1.8		X Walk 2 X Slope (%)	1.3

N/A	Ramp inside XWalk1?	N/A	N/A	Ramp inside XWalk2?	N/A
	Road Slope (%)	1.9		Clear Space?	N/A
	Road X Slope (%)	1.4	N/A	Clear Space to XWalk (in)	N/A
N/A	Any Obstructions?	N/A	N/A	Storm Grate/Utility Hazard?	N/A
	Obstruction Type			Storm Grate/Utility Type	
		N/A			N/A
			Yes	Surface Condition? (G/P)	Good
			No	Curb Slope (%)	13.4

**Remove & Replace Curb Ramp With Two New Directional Ramps or Equivalent.**
