Access Compliance Report

Public Rights-of-Way

(Curb Ramps)

Intersection ID: N/A	Main Street: ARROWOOD_RD	Cross Street: ROYAL_POINT_DR	Location: SE
ADA ID: D945040206C3	Ramp Type: Directional1	Initial Pass/Fail: Fail	Overall Compliance: No
		Severity Score: 50

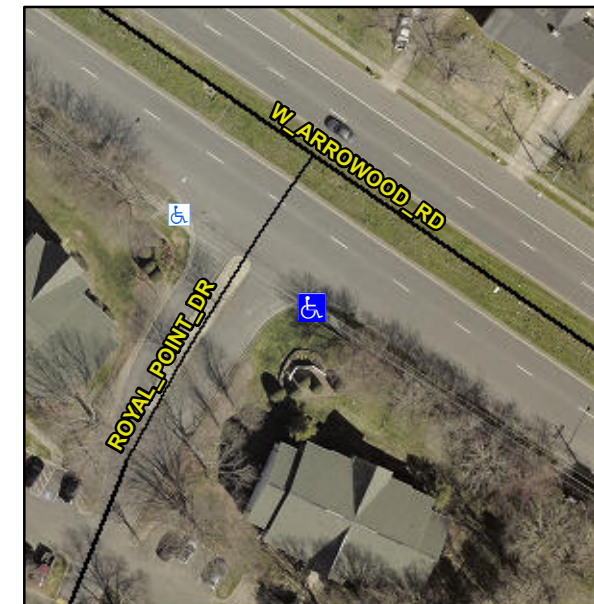
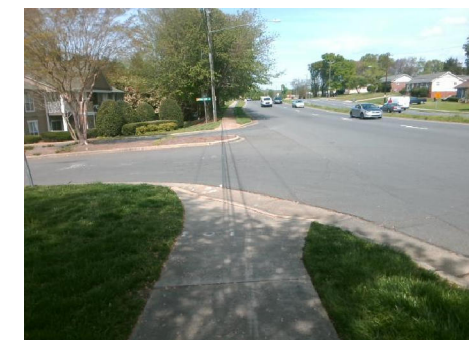
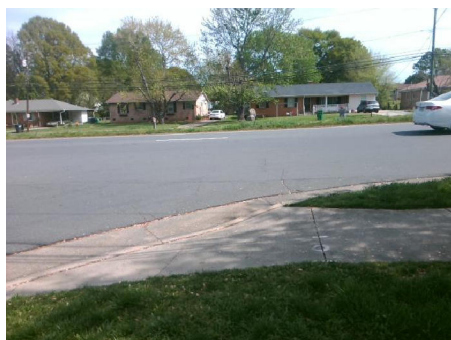
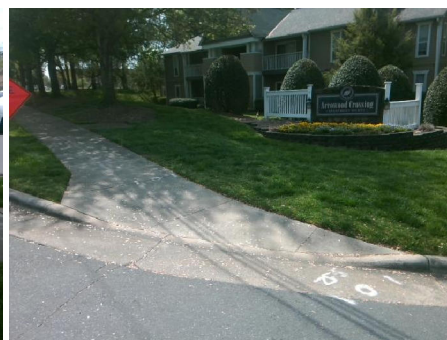
R304.2.2, R304.5.3

Compliance	Description	Data	Compliance	Description	Data
N/A	Ramp Length (in)	24.0	N/A	Grade Break?	N/A
Yes	Ramp Width (in)	60.0	N/A	Grade Break Slope (%)	0.0
No	Ramp Slope (%)	12.3	N/A	Grade Break XSlope (%)	0.0
No	Ramp XSlope (%)	7.1			
N/A	Flare Type LT	N/A	N/A	Flare Type RT	N/A
N/A	Flare Slope LT (%)	N/A	N/A	Flare Slope RT (%)	0.0
N/A	Flare Traversable LT?	N/A	N/A	Flare Traversable RT?	N/A
N/A	Landing Length (in)	0.0	N/A	DWS Provided?	N/A
N/A	Landing Width (in)	0.0	N/A	DWS Contrast?	N/A
N/A	Landing Slope (%)	0.0	N/A	DWS Length (in)	N/A
N/A	Landing X Slope (%)	0.0	N/A	DWS Full Width?	N/A
N/A	Landing Curb? (Y/N)	N/A	N/A	DWS Offset LT (in)	N/A
N/A	Shared Landing?	N/A	N/A	DWS Offset RT (in)	N/A
N/A	Gutter Ponding?	0.0	N/A	Gutter Slope (%)	N/A
N/A	Gutter Lip Ht (in)	0.0	N/A	Gutter X Slope (%)	N/A
N/A	Painted X Walk1?	No		Road Slope (%)	1.6
	X Walk 1 Direction	To W		Road X Slope (%)	6.0
	X Walk 1 Width (in)	N/A		Clear Space?	N/A

X Walk 1 Slope (%)	1.6	N/A	Clear Space to XWalk (in)	N/A
	X Walk 1 X Slope (%)	6.0	N/A	Storm Grate/Utility Hazard?	N/A
N/A	Ramp inside XWalk1?	N/A		Storm Grate/Utility Type	
N/A	Any Obstructions?	N/A			N/A
	Obstruction Type		Yes	Surface Condition? (G/P)	Good
			N/A	Curb Slope (%)	6.4

Remove & Replace Entire Ramp.
