Access Compliance Report

Public Rights-of-Way

(Curb Ramps)

Intersection ID: 45515	Main Street: COTTON_PRESS_RD	Cross Street: HEDGEROW_PARK_RD	Location: SE
ADA ID: D945D440E7C0	Ramp Type: PerpDiag	Initial Pass/Fail: Fail	Overall Compliance: No
Severity Score: 8.75			
Codes/Mitigation Info/Possible Solution		Field Measurements/Component Compliance

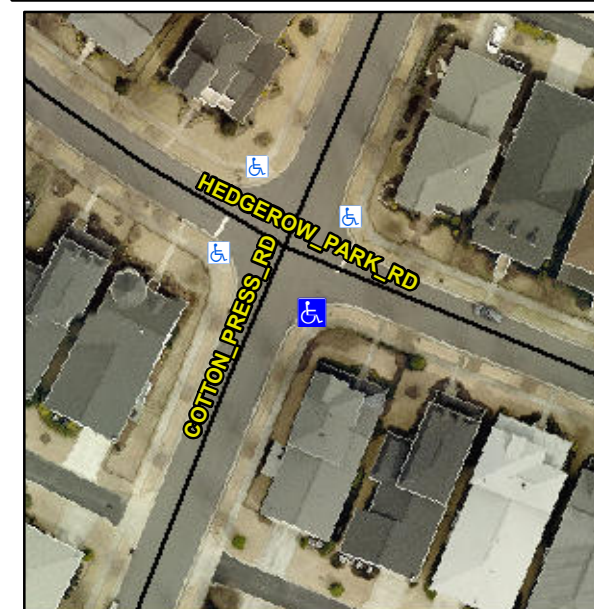
Compliance	Description	Data	Compliance	Description	Data
N/A	Ramp Length (in)	72.0	Yes	Ramp Slope (%)	7.8
No	Ramp Width (in)	44.0	Yes	Ramp XSlope (%)	1.9
N/A	Flare Type LT	N/A	N/A	Flare Type RT	N/A
N/A	Flare Slope LT (%)	N/A	N/A	Flare Slope RT (%)	N/A
N/A	Flare Traversable LT?	N/A	N/A	Flare Traversable RT?	N/A
N/A	Landing Length (in)	N/A	N/A	DWS Provided?	N/A
N/A	Landing Width (in)	N/A	N/A	DWS Contrast?	N/A
N/A	Landing Slope (%)	N/A	N/A	DWS Length (in)	N/A
N/A	Landing X Slope (%)	N/A	N/A	DWS Full Width?	N/A
N/A	Landing Curb? (Y/N)	N/A	N/A	DWS Offset (in)	N/A
N/A	Shared Landing?	N/A			
N/A	Gutter Ponding?	N/A	N/A	Gutter Slope (%)	N/A
N/A	Gutter Lip Ht (in)	N/A	N/A	Gutter X Slope (%)	N/A
N/A	Painted X Walk1?	No	N/A	Painted X Walk2?	No
	X Walk 1 Direction	To NE		X Walk 2 Direction	To NW
N/A	X Walk 1 Width (in)	N/A	N/A	X Walk 2 Width (in)	N/A
	X Walk 1 Slope (%)	1.7		X Walk 2 Slope (%)	2.0
	X Walk 1 X Slope (%)	2.3		X Walk 2 X Slope (%)	1.6

N/A	Ramp inside XWalk1?	N/A	N/A	Ramp inside XWalk2?	N/A
	Road Slope (%)	1.0	N/A	Clear Space?	N/A
	Road X Slope (%)	1.2	N/A	Clear Space to XWalk (in)	N/A
N/A	Any Obstructions?	N/A	N/A	Storm Grate/Utility Hazard?	N/A
	Obstruction Type			Storm Grate/Utility Type	
		N/A			N/A
			Yes	Surface Condition? (G/P)	Good

Possible Solutions:

Remove & Replace Curb Ramp With Two New Directional Ramps or Equivalent.

R304.5.1
