Access Compliance Report Public Rights-of-Way (Curb Ramps)

Intersection ID: 10020275Main Street: AYRSLEY_TOWN_BVCross Street: N/ALocation: NWADA ID: D94610E284D9Ramp Type: PerpInitial Pass/Fail: FailOverall Compliance: NoSeverity Score: 12.5

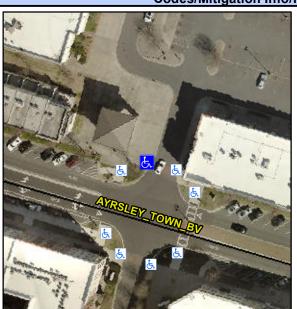
| Possible Solution | | Field Measurements/Component Compnance | | | | | | |
|---|---|--|---|---|---|---|--|--|
| Remove & Replace Entire Ramp |) . | N/A | Ramp Length (in) | 95.0 | No Ra | amp Slope (%) | | |

Codes/Mitigation Info/Possible Solution

| Possible Solution | | Field Measurements/Component Compnance | | | | | | |
|---|---|--|---|---|---|---|--|--|
| Total Cost: \$ | 1850.00 | | Obstruction Type | | St | orm Grate/Utility Type | | |
