Access Compliance Report

Public Rights-of-Way

(Curb Ramps)

Intersection ID: 17207	Main Street: CHILTON_PL	Cross Street: QUEENS_RD_EAST	Location: E
ADA ID: D94D17F17FAB	Ramp Type: PerpDiag	Initial Pass/Fail: Fail	Overall Compliance: No
Severity Score: 22.5			
Codes/Mitigation Info/Possible Solution		Field Measurements/Component Compliance

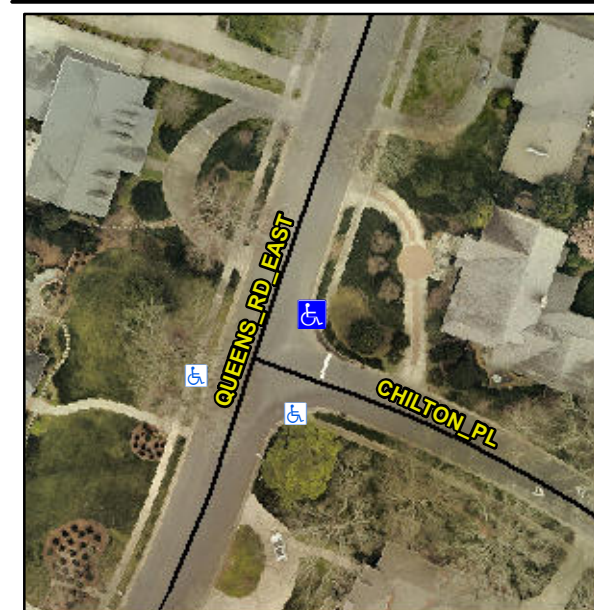
Not Found, R304.5.1, R304.2.2, R304.5.3

Compliance	Description	Data	Compliance	Description	Data
N/A	Ramp Length (in)	48.0	No	Ramp Slope (%)	10.8
No	Ramp Width (in)	46.0	No	Ramp XSlope (%)	2.1
N/A	Flare Type LT	N/A	N/A	Flare Type RT	N/A
N/A	Flare Slope LT (%)	N/A	N/A	Flare Slope RT (%)	N/A
N/A	Flare Traversable LT?	N/A	N/A	Flare Traversable RT?	N/A
N/A	Landing Length (in)	N/A	N/A	DWS Provided?	N/A
N/A	Landing Width (in)	N/A	N/A	DWS Contrast?	N/A
N/A	Landing Slope (%)	N/A	N/A	DWS Length (in)	N/A
N/A	Landing X Slope (%)	N/A	N/A	DWS Full Width?	N/A
N/A	Landing Curb? (Y/N)	N/A	N/A	DWS Offset (in)	N/A
N/A	Shared Landing?	N/A			
N/A	Gutter Ponding?	N/A	N/A	Gutter Slope (%)	N/A
N/A	Gutter Lip Ht (in)	N/A	N/A	Gutter X Slope (%)	N/A
N/A	Painted X Walk1?	No	N/A	Painted X Walk2?	No
	X Walk 1 Direction	To W		X Walk 2 Direction	To SW
N/A	X Walk 1 Width (in)	N/A	N/A	X Walk 2 Width (in)	N/A
	X Walk 1 Slope (%)	2.8		X Walk 2 Slope (%)	0.9
	X Walk 1 X Slope (%)	0.4		X Walk 2 X Slope (%)	4.1

N/A	Ramp inside XWalk1?	N/A	N/A	Ramp inside XWalk2?	N/A
	Road Slope (%)	3.4	N/A	Clear Space?	N/A
	Road X Slope (%)	6.8	N/A	Clear Space to XWalk (in)	N/A
N/A	Any Obstructions?	N/A	N/A	Storm Grate/Utility Hazard?	N/A
	Obstruction Type			Storm Grate/Utility Type	
		N/A			N/A
			Yes	Surface Condition? (G/P)	Good

Possible Solutions:

Remove & Replace Curb Ramp With Two New Directional Ramps or Equivalent.
