Access Compliance Report

Public Rights-of-Way

(Curb Ramps)

Intersection ID: 51044	Main Street: KENDALL_DR	Cross Street: LONGNOR_ST	Location: NE
ADA ID: D94FD5F38F58	Ramp Type: Perp	Initial Pass/Fail: Fail	Overall Compliance: No
		Severity Score: 12.5

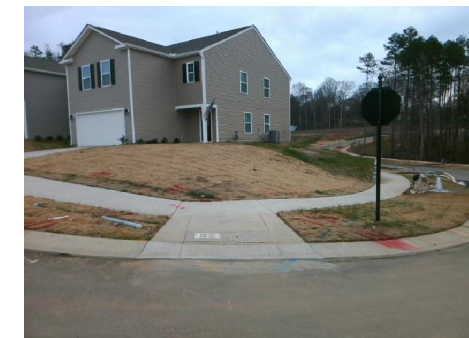
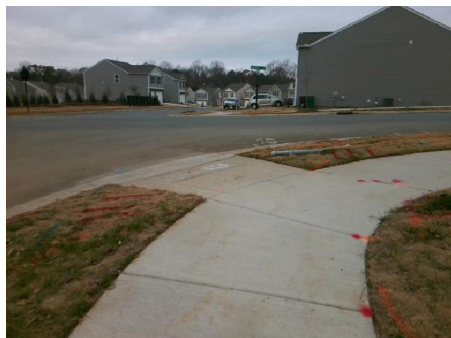
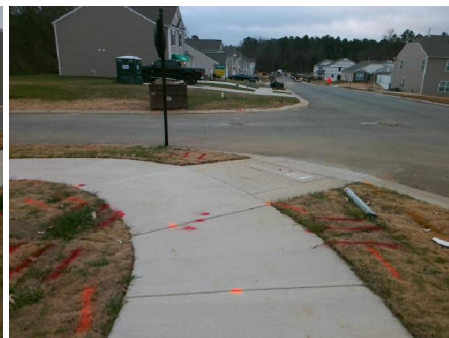
Not Found, R304.5.3

Compliance	Description	Data	Compliance	Description	Data
N/A	Ramp Length (in)	72.0	Yes	Ramp Slope (%)	6.0
Yes	Ramp Width (in)	58.0	No	Ramp XSlope (%)	6.6
N/A	Flare Type LT	N/A	N/A	Flare Type RT	N/A
N/A	Flare Slope LT (%)	N/A	N/A	Flare Slope RT (%)	N/A
N/A	Flare Traversable LT?	N/A	N/A	Flare Traversable RT?	N/A
N/A	Landing Length (in)	N/A	N/A	DWS Provided?	N/A
N/A	Landing Width (in)	N/A	N/A	DWS Contrast?	N/A
N/A	Landing Slope (%)	N/A	N/A	DWS Length (in)	N/A
N/A	Landing X Slope (%)	N/A	N/A	DWS Full Width?	N/A
N/A	Landing Curb? (Y/N)	N/A	N/A	DWS Offset (in)	N/A
N/A	Shared Landing?	N/A			
N/A	Gutter Ponding?	N/A	N/A	Gutter Slope (%)	N/A
N/A	Gutter Lip Ht (in)	N/A	N/A	Gutter X Slope (%)	N/A
N/A	Painted X Walk1?	No	N/A	Painted X Walk2?	N/A
	X Walk 1 Direction	To W		X Walk 2 Direction	N/A
N/A	X Walk 1 Width (in)	N/A	N/A	X Walk 2 Width (in)	N/A
	X Walk 1 Slope (%)	9.7		X Walk 2 Slope (%)	N/A
	X Walk 1 X Slope (%)	4.6		X Walk 2 X Slope (%)	N/A

N/A	Ramp inside XWalk1?	N/A	N/A	Ramp inside XWalk2?	N/A
	Road Slope (%)	N/A	N/A	Clear Space?	N/A
	Road X Slope (%)	N/A	N/A	Clear Space to XWalk (in)	N/A
N/A	Any Obstructions?	N/A	N/A	Storm Grate/Utility Hazard?	N/A
	Obstruction Type			Storm Grate/Utility Type	
		N/A			N/A
			Yes	Surface Condition? (G/P)	Good

Remove & Replace Entire Ramp.

Total Cost: \$ 1850.00
