# Access Compliance Report

## Public Rights-of-Way

| Intersection ID: 45240 | Main Street: BEGONIA_DR | Cross Street: BLAZE_MANOR_LN | Location: SW |
| ADA ID: D95A16D4EE40 | Ramp Type: PerpDiag | Initial Pass/Fail: Pass | Overall Compliance: No |

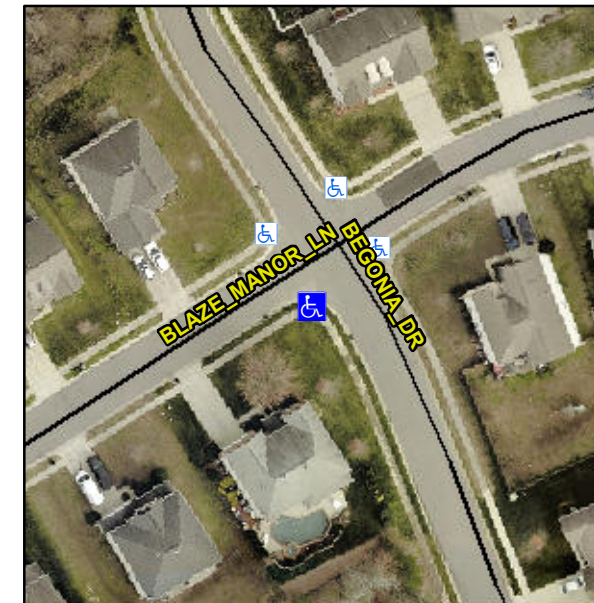
**Not Found, R304.2.1, R302.7, R302.7.2, R304.5.4**

| Compliance | Description | Data | Compliance | Description | Data |
|---|---|---|---|---|---|
| No | Landing Length (in) | 46.5 | Yes | DWS Provided? | Yes |
| No | Gutter Ponding? | Yes | No | Gutter Slope (%) | 12.6 |
| No | Gutter Lip Ht (in) | 0.5 | Yes | Gutter X Slope (%) | 0.1 |

**Remove & Replace Curb Ramp With Two New Directional Ramps or Equivalent. Remove & Replace Gutter.**
