# Access Compliance Report

## Public Rights-of-Way

### (Curb Ramps)

| Intersection ID: 9765 | Main Street: RUSH_WIND_DR | Cross Street: TINNIN_AV | Location: SW |

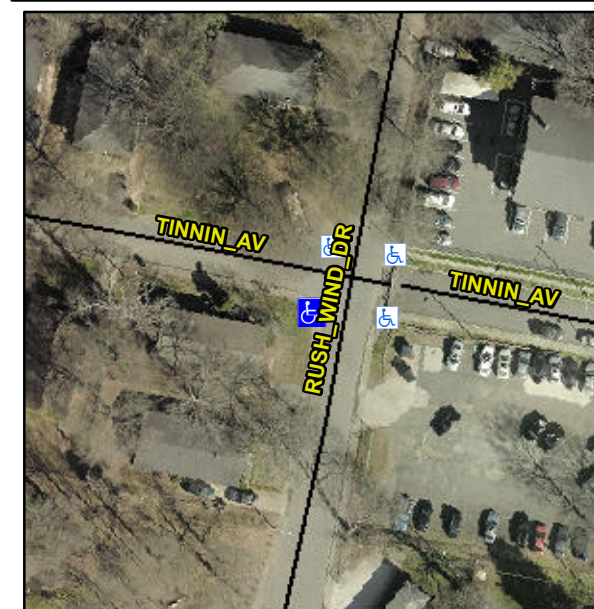
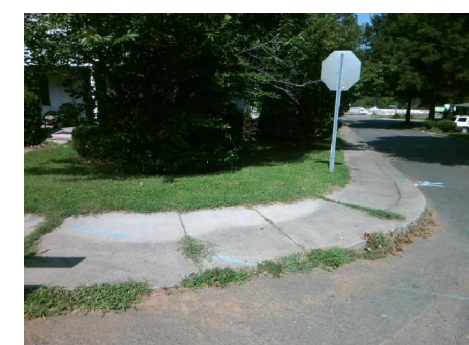
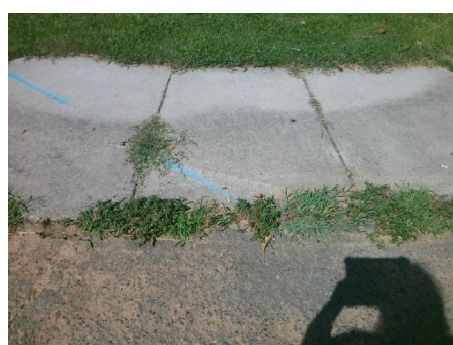
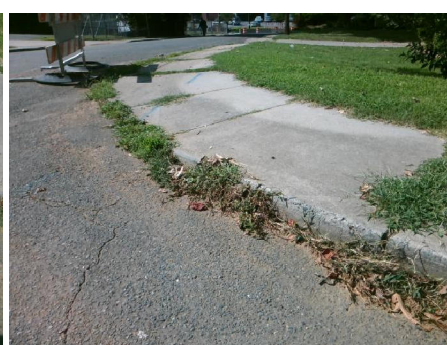
| ADA ID: D9641769BFFA | Ramp Type: Perp | Initial Pass/Fail: Fail | Overall Compliance: No |
| Severity Score: 22.5 | | | |

**R304.5.1, R304.2.2, R304.5.3**

| Compliance | Description | Data | Compliance | Description | Data |
|---|---|---|---|---|---|
| N/A | Ramp Length (in) | 62.5 | No | Ramp Slope (%) | 10.2 |
| No | Ramp Width (in) | 39.0 | No | Ramp XSlope (%) | 4.4 |

**Remove & Replace Entire Ramp.**
