| Intersection ID: 8285 | Main Street: CATHERINE_SIMMONS_AV | Cross Street: HAINES_ST | Location: | NE |
| ADA ID: D965620C04C4 | Ramp Type: PerpDiag | Initial Pass/Fail: Fail | Overall Compliance: No | Severity Score: 17.5 |

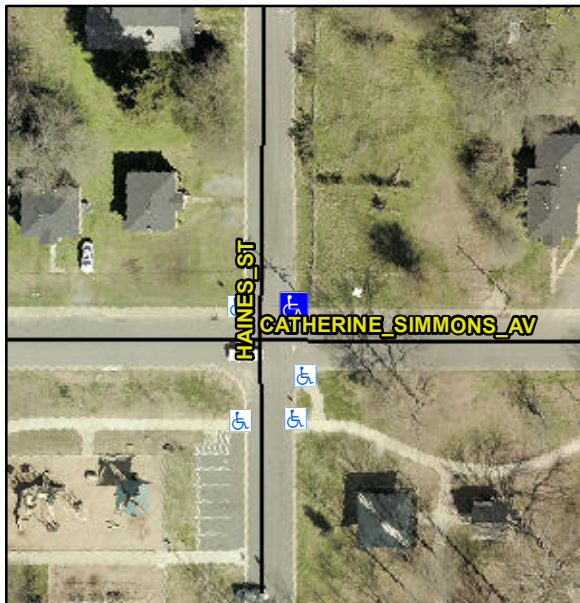
| Codes/Mitigation Info/Possible Solution | | | Field Measurements/Component Compliance | | | | | |
|---|---|---|---|---|---|---|---|---|
| | | | No | Ramp Width (in) | 32.5 | Yes | Ramp XSlope (%) | 0.6 |
| <b>R304.5.1</b> | | N/A | Gutter Ponding? | N/A | N/A | Gutter Slope (%) | N/A | |

| Codes/Mitigation Info/Possible Solution | | | Field Measurements/Component Compliance | | | | | |
|---|---|---|---|---|---|---|---|---|
| | <b>Remove &amp; Replace Curb Ramp With Two New Directional Ramps or Equivalent.</b> | | N/A | Ramp Length (in) | 39.0 | Yes | Ramp Slope (%) | 8.0 |
