# Access Compliance Report

## Public Rights-of-Way

### (Curb Ramps)

| Intersection ID: 7225 | Main Street: STATESVILLE_RD | Cross Street: STARITA_RD | Location: NW |

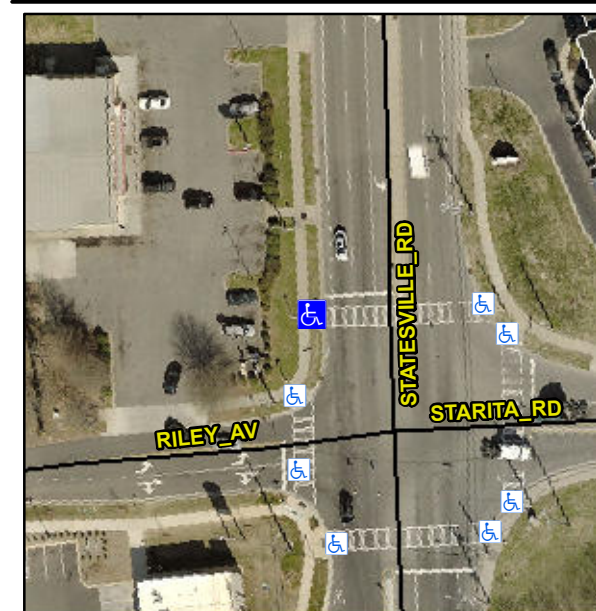
| ADA ID: D9685654210C | Ramp Type: Perp | Initial Pass/Fail: Pass | Overall Compliance: No |
| Severity Score: 5 | | | |

**Not Found, R304.2.1, R304.2.2-Perp,  
R304.3.2-Para, R304.5.4**

| Compliance | Description | Data | Compliance | Description | Data |
|---|---|---|---|---|---|
| No | Landing Length (in) | 23.0 | Yes | DWS Provided? | Yes |
| No | Landing Slope (%) | 2.6 | Yes | DWS Length (in) | 24.0 |
| Yes | Gutter Ponding? | No | No | Gutter Slope (%) | 7.4 |

**Remove & Replace Entire Ramp.  
Remove & Replace Gutter.**

Total Cost: \$ 2600.00
