# Access Compliance Report

## Public Rights-of-Way

### (Curb Ramps)

Intersection ID: 53357	Main Street: SEEGARS_PL	Cross Street: HELTON_WY	Location: SW
ADA ID: D96C1CA36F22	Ramp Type: BlendTrans2	Initial Pass/Fail: Pass	Overall Compliance: No
Severity Score: 25			
Codes/Mitigation Info/Possible Solution		Field Measurements/Component Compliance

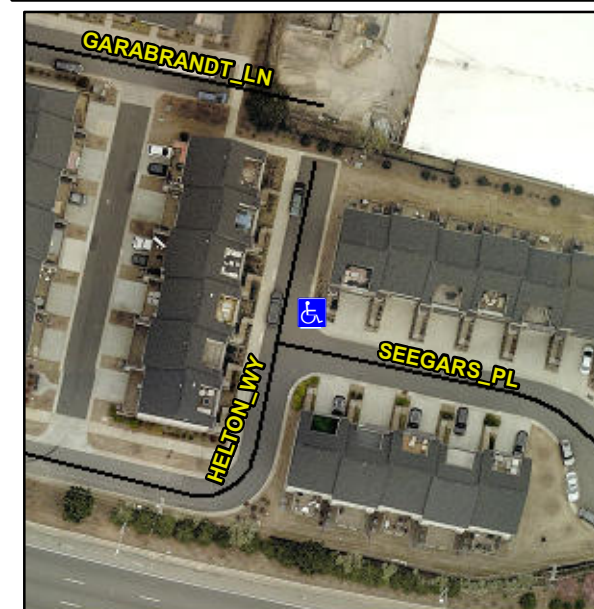
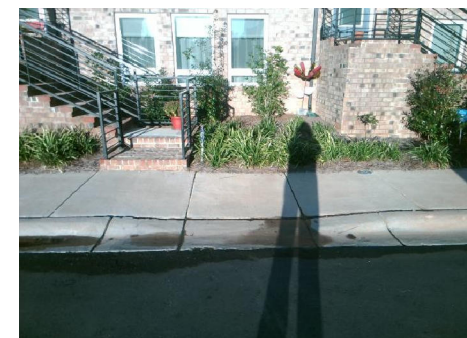
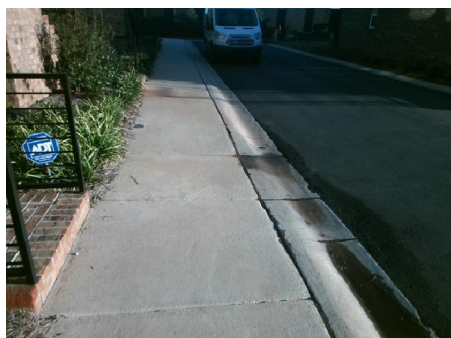
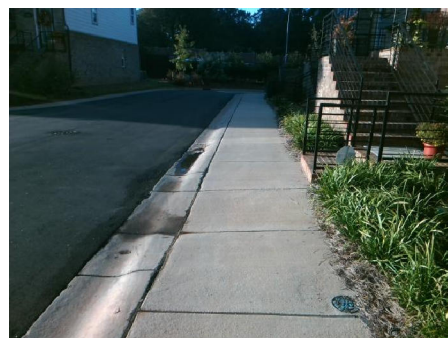
**Not Found, R304.2.3, R305, R302.7, R302.7.2, R304.5.4**

Compliance	Description	Data	Compliance	Description	Data
N/A	Ramp Length (in)	58.0	Yes	BlendTrans Slope (%)	4.7
Yes	Ramp Width (in)	48.0	Yes	BlendTrans XSlope (%)	0.7
N/A	Flare Type LT	Sloped	N/A	Flare Type RT	Sloped
Yes	Flare Slope LT (%)	5.4	No	Flare Slope RT (%)	11.0
N/A	Flare Traversable LT?	Yes	N/A	Flare Traversable RT?	Yes
N/A	Landing Length (in)	N/A	No	DWS Provided?	No
N/A	Landing Width (in)	N/A	N/A	DWS Contrast?	No
N/A	Landing Slope (%)	N/A	N/A	DWS Length (in)	N/A
N/A	Landing X Slope (%)	N/A	N/A	DWS Full Width?	No
N/A	Landing Curb? (Y/N)	No	N/A	DWS Offset (in)	N/A
N/A	Shared Landing?	No			
No	Gutter Ponding?	Yes	No	Gutter Slope (%)	6.0
No	Gutter Lip Ht (in)	0.3	Yes	Gutter X Slope (%)	0.4
N/A	Painted X Walk1?	No	N/A	Painted X Walk2?	N/A
	X Walk 1 Direction	To NE		X Walk 2 Direction	N/A
	X Walk 1 Width (in)	N/A		X Walk 2 Width (in)	N/A
	X Walk 1 Slope (%)	3.8		X Walk 2 Slope (%)	N/A
	X Walk 1 X Slope (%)	0.8		X Walk 2 X Slope (%)	N/A

N/A	Ramp inside XWalk1?	N/A	N/A	Ramp inside XWalk2?	N/A
	Road Slope (%)	0.8		Clear Space?	Yes
	Road X Slope (%)	3.8	N/A	Clear Space to XWalk (in)	N/A
Yes	Any Obstructions?	No	Yes	Storm Grate/Utility Hazard?	No
	Obstruction Type			Storm Grate/Utility Type	
		N/A			N/A
			Yes	Surface Condition? (G/P)	Good
			No	Curb Slope (%)	6.4

**Remove & Replace Curb Ramp With Two New Directional Ramps or Equivalent. Remove & Replace Gutter.**
