Access Compliance Report

Public Rights-of-Way

(Curb Ramps)

Intersection ID: 4232	Main Street: SALOME_CHURCH_RD	Cross Street: STONEY_VIEW_DR	Location: SW
ADA ID: D98B7084E444	Ramp Type: BlendTrans1	Initial Pass/Fail: Pass	Overall Compliance: No
Severity Score: 17.5			
Codes/Mitigation Info/Possible Solution		Field Measurements/Component Compliance

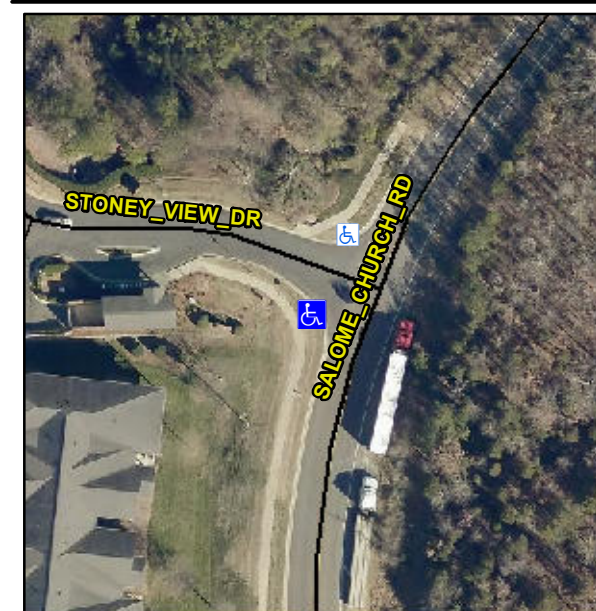
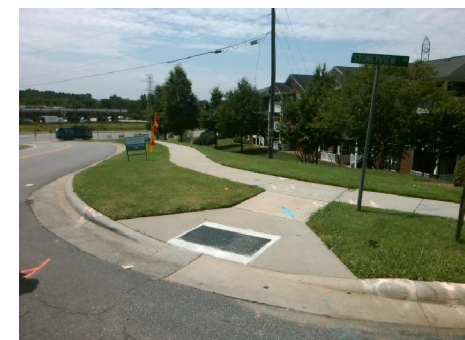
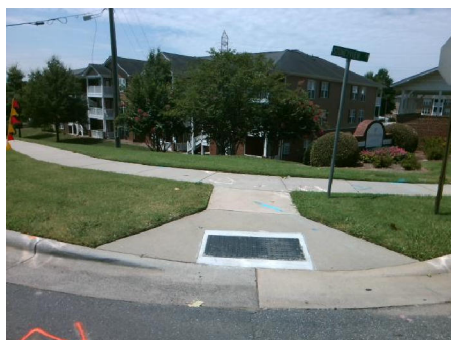
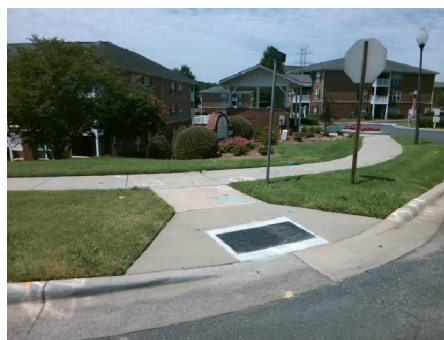
Not Found, R305.1.4, R305.2, R302.7.2, R304.5.3

Compliance	Description	Data	Compliance	Description	Data
N/A	Ramp Length (in)	127.0	Yes	BlendTrans Slope (%)	4.4
Yes	Ramp Width (in)	52.0	Yes	BlendTrans XSlope (%)	0.3
N/A	Flare Type LT	Sloped	N/A	Flare Type RT	Sloped
N/A	Flare Slope LT (%)	6.7	N/A	Flare Slope RT (%)	6.7
N/A	Flare Traversable LT?	No	N/A	Flare Traversable RT?	No
Yes	Landing Length (in)	60.0	Yes	DWS Provided?	Yes
Yes	Landing Width (in)	59.0	Yes	DWS Contrast?	Yes
Yes	Landing Slope (%)	0.0	Yes	DWS Length (in)	24.0
Yes	Landing X Slope (%)	0.0	No	DWS Full Width?	No
N/A	Landing Curb? (Y/N)	No	No	DWS Offset (in)	7.0
N/A	Shared Landing?	No			
Yes	Gutter Ponding?	No	Yes	Gutter Slope (%)	2.1
No	Gutter Lip Ht (in)	0.75	No	Gutter X Slope (%)	4.4
N/A	Painted X Walk1?	No	N/A	Painted X Walk2?	N/A
	X Walk 1 Direction	To N		X Walk 2 Direction	N/A
	X Walk 1 Width (in)	N/A		X Walk 2 Width (in)	N/A
	X Walk 1 Slope (%)	2.0		X Walk 2 Slope (%)	N/A
	X Walk 1 X Slope (%)	0.8		X Walk 2 X Slope (%)	N/A

N/A	Ramp inside XWalk1?	N/A	N/A	Ramp inside XWalk2?	N/A
	Road Slope (%)	0.8		Clear Space?	Yes
	Road X Slope (%)	2.0	N/A	Clear Space to XWalk (in)	N/A
Yes	Any Obstructions?	No	Yes	Storm Grate/Utility Hazard?	No
	Obstruction Type			Storm Grate/Utility Type	
			N/A		N/A
			Yes	Surface Condition? (G/P)	Good
			No	Curb Slope (%)	17.4

Remove & Replace Curb Ramp With Two New Directional Ramps or Equivalent. Remove & Replace Gutter.
