# Access Compliance Report

## Public Rights-of-Way

### (Curb Ramps)

| Intersection ID: 29429 | Main Street: BRADSTREET_COMMONS_WY | Cross Street: DELUCA_DR | Location: NE |

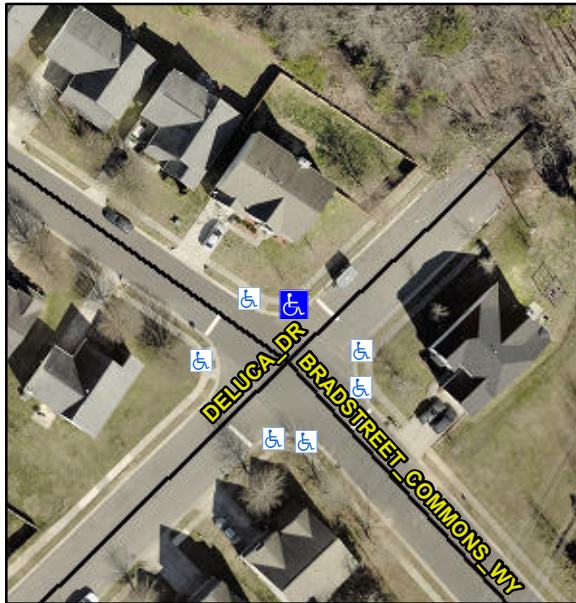
**Not Found, R304.5.3, R304.2.1, R304.2.2-Perp, R304.3.2-Para, R305.2, R302.7, R304.5.4**

| Compliance | Description | Data | Compliance | Description | Data |
|---|---|---|---|---|---|
| Yes | Ramp Width (in) | 48.0 | No | BlendTrans XSlope (%) | 3.2 |
| No | Landing Width (in) | 46.5 | Yes | DWS Contrast? | Yes |
| No | Landing Slope (%) | 4.3 | Yes | DWS Length (in) | 24.5 |
| No | Gutter Ponding? | Yes | No | Gutter Slope (%) | 5.8 |
| Yes | Gutter Lip Ht (in) | 0.0 | No | Gutter X Slope (%) | 3.8 |

**Remove & Replace Curb Ramp With Two New Directional Ramps or Equivalent. Remove & Replace Gutter.**
