Intersection ID: 11694	Main Street: ANNE_ST	Cross Street: COUNTRY_CLUB_DR	Location:	W
ADA ID: D9B114D232C4	Ramp Type: Perp	Initial Pass/Fail: Fail	Overall Compliance: No	Severity Score: 12.5

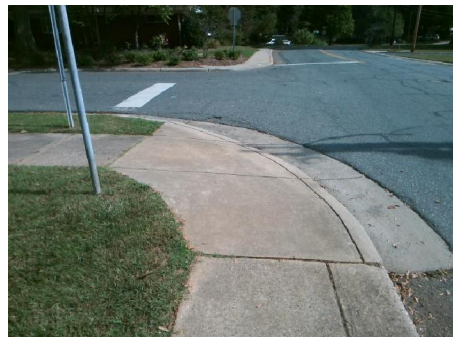
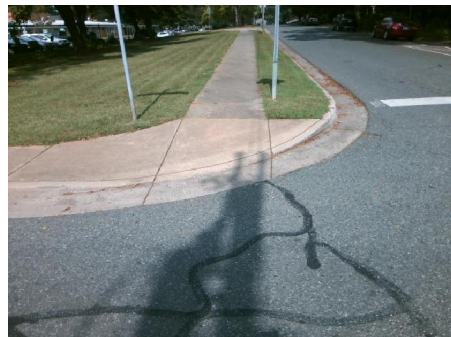
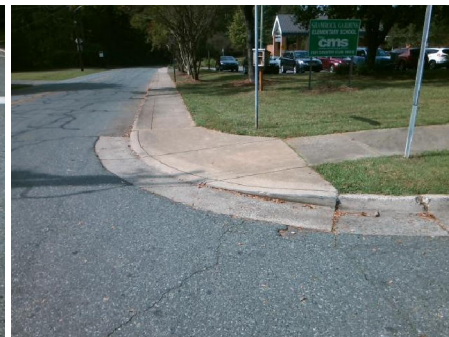
Not Found, R304.2.2

Compliance	Description	Data	Compliance	Description	Data
N/A	Ramp Length (in)	52.0	No	Ramp Slope (%)	8.8
Yes	Ramp Width (in)	58.0	Yes	Ramp XSlope (%)	1.7
N/A	Flare Type LT	N/A	N/A	Flare Type RT	N/A
N/A	Flare Slope LT (%)	N/A	N/A	Flare Slope RT (%)	N/A
N/A	Flare Traversable LT?	N/A	N/A	Flare Traversable RT?	N/A
N/A	Landing Length (in)	N/A	N/A	DWS Provided?	N/A
N/A	Landing Width (in)	N/A	N/A	DWS Contrast?	N/A
N/A	Landing Slope (%)	N/A	N/A	DWS Length (in)	N/A
N/A	Landing X Slope (%)	N/A	N/A	DWS Full Width?	N/A
N/A	Landing Curb? (Y/N)	N/A	N/A	DWS Offset (in)	N/A
N/A	Shared Landing?	N/A			
N/A	Gutter Ponding?	N/A	N/A	Gutter Slope (%)	N/A
N/A	Gutter Lip Ht (in)	N/A	N/A	Gutter X Slope (%)	N/A
N/A	Painted X Walk1?	No	N/A	Painted X Walk2?	N/A
	X Walk 1 Direction	To E		X Walk 2 Direction	N/A
N/A	X Walk 1 Width (in)	N/A	N/A	X Walk 2 Width (in)	N/A
	X Walk 1 Slope (%)	3.3		X Walk 2 Slope (%)	N/A
	X Walk 1 X Slope (%)	0.6		X Walk 2 X Slope (%)	N/A

Remove & Replace Entire Ramp.
