Access Compliance Report

Public Rights-of-Way

(Curb Ramps)

Intersection ID: N/A	Main Street: TRYON_ST	Cross Street: ANANDALE_DR	Location: NE
ADA ID: D9B16C3651AE	Ramp Type: PerpDiag	Initial Pass/Fail: Pass	Overall Compliance: No
		Severity Score: 20

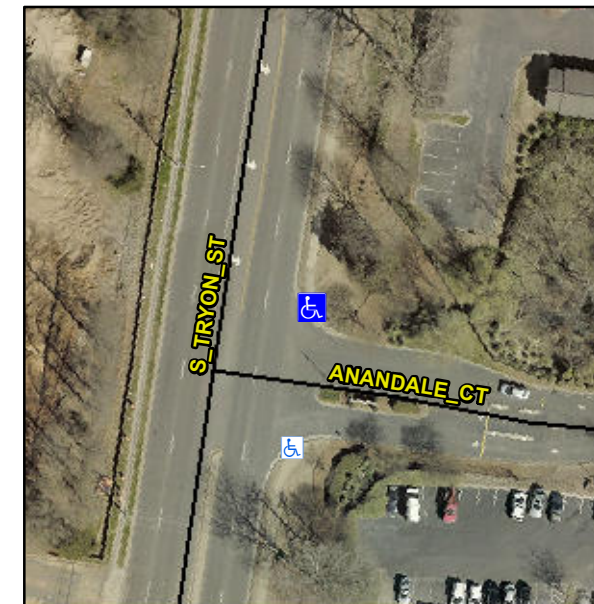
Compliance	Description	Data	Compliance	Description	Data
N/A	Ramp Length (in)	90.0	Yes	Ramp Slope (%)	5.5
Yes	Ramp Width (in)	48.0	Yes	Ramp XSlope (%)	1.9
N/A	Flare Type LT	Sloped	N/A	Flare Type RT	N/A
N/A	Flare Slope LT (%)	9.3	N/A	Flare Slope RT (%)	1.6
N/A	Flare Traversable LT?	Yes	N/A	Flare Traversable RT?	No
No	Landing Length (in)	N/A	No	DWS Provided?	No
No	Landing Width (in)	N/A	N/A	DWS Contrast?	No
No	Landing Slope (%)	N/A	N/A	DWS Length (in)	N/A
No	Landing X Slope (%)	N/A	N/A	DWS Full Width?	No
N/A	Landing Curb? (Y/N)	No	N/A	DWS Offset (in)	N/A
N/A	Shared Landing?	No			
Yes	Gutter Ponding?	No	Yes	Gutter Slope (%)	0.1
Yes	Gutter Lip Ht (in)	0.0	No	Gutter X Slope (%)	2.8
N/A	Painted X Walk1?	No	N/A	Painted X Walk2?	No
	X Walk 1 Direction	To W		X Walk 2 Direction	To S
N/A	X Walk 1 Width (in)	N/A	N/A	X Walk 2 Width (in)	N/A
	X Walk 1 Slope (%)	1.2		X Walk 2 Slope (%)	5.7
	X Walk 1 X Slope (%)	2.2		X Walk 2 X Slope (%)	4.4

N/A	Ramp inside XWalk1?	N/A	N/A	Ramp inside XWalk2?	N/A
	Road Slope (%)	0.1	N/A	Clear Space?	Yes
	Road X Slope (%)	2.8	N/A	Clear Space to XWalk (in)	N/A
Yes	Any Obstructions?	No	Yes	Storm Grate/Utility Hazard?	No
	Obstruction Type			Storm Grate/Utility Type	
		N/A			N/A
			Yes	Surface Condition? (G/P)	Good

Remove & Replace Curb Ramp With Two New Directional Ramps or Equivalent. Remove & Replace Gutter.

R304.2.1, R304.2.2-Perp, R304.3.2-Para, R304.5.3, R305
