Access Compliance Report

Public Rights-of-Way

(Curb Ramps)

Intersection ID: 52928	Main Street: GRAY_OAK_LN	Cross Street: MAPLE_OAK_DR	Location: NW
ADA ID: D9B2202ED7D2	Ramp Type: Perp	Initial Pass/Fail: Fail	Overall Compliance: No
Severity Score: 8.75			
Codes/Mitigation Info/Possible Solution		Field Measurements/Component Compliance

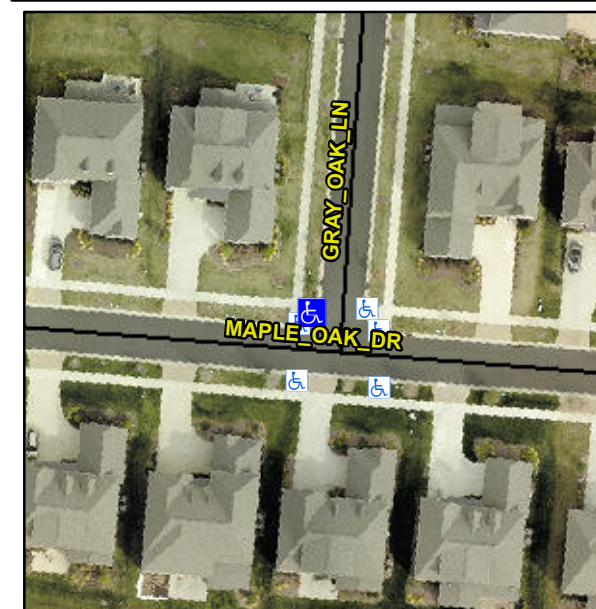
Compliance	Description	Data	Compliance	Description	Data
N/A	Ramp Length (in)	36.5	Yes	Ramp Slope (%)	7.1
No	Ramp Width (in)	47.5	Yes	Ramp XSlope (%)	0.5
N/A	Flare Type LT	N/A	N/A	Flare Type RT	N/A
N/A	Flare Slope LT (%)	N/A	N/A	Flare Slope RT (%)	N/A
N/A	Flare Traversable LT?	N/A	N/A	Flare Traversable RT?	N/A
N/A	Landing Length (in)	N/A	N/A	DWS Provided?	N/A
N/A	Landing Width (in)	N/A	N/A	DWS Contrast?	N/A
N/A	Landing Slope (%)	N/A	N/A	DWS Length (in)	N/A
N/A	Landing X Slope (%)	N/A	N/A	DWS Full Width?	N/A
N/A	Landing Curb? (Y/N)	N/A	N/A	DWS Offset (in)	N/A
N/A	Shared Landing?	N/A			
N/A	Gutter Ponding?	N/A	N/A	Gutter Slope (%)	N/A
N/A	Gutter Lip Ht (in)	N/A	N/A	Gutter X Slope (%)	N/A
N/A	Painted X Walk1?	No	N/A	Painted X Walk2?	N/A
	X Walk 1 Direction	To E		X Walk 2 Direction	N/A
N/A	X Walk 1 Width (in)	N/A	N/A	X Walk 2 Width (in)	N/A
	X Walk 1 Slope (%)	2.0		X Walk 2 Slope (%)	N/A
	X Walk 1 X Slope (%)	0.7		X Walk 2 X Slope (%)	N/A

N/A	Ramp inside XWalk1?	N/A	N/A	Ramp inside XWalk2?	N/A
	Road Slope (%)	N/A	N/A	Clear Space?	N/A
	Road X Slope (%)	N/A	N/A	Clear Space to XWalk (in)	N/A
N/A	Any Obstructions?	N/A	N/A	Storm Grate/Utility Hazard?	N/A
	Obstruction Type			Storm Grate/Utility Type	
		N/A			N/A
		Yes		Surface Condition? (G/P)	Good

Possible Solutions:

Remove & Replace Entire Ramp.

R304.5.1

\$ 1850.00
