# Access Compliance Report

## Public Rights-of-Way

### (Curb Ramps)

| Intersection ID: 53351 | Main Street: MARVIN_RD | Cross Street: SAPPHIRE_HILL_LN | Location: SE |

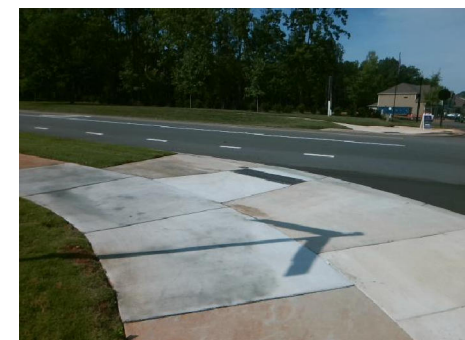
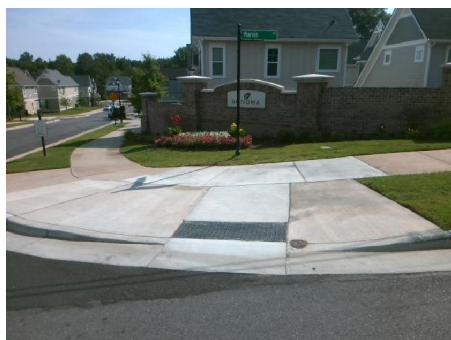
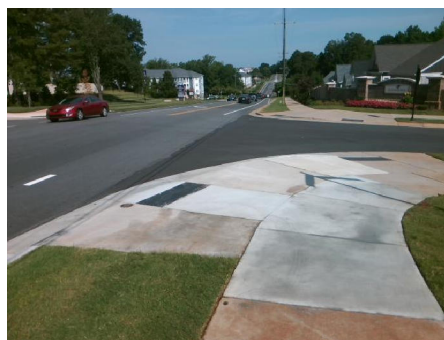
| ADA ID: D9B5D07E526E | Ramp Type: BlendTrans1 | Initial Pass/Fail: Fail | Overall Compliance: No |
| | | Severity Score: 25 | |

**R304.5.3**

| Compliance | Description | Data | Compliance | Description | Data |
|---|---|---|---|---|---|
| Yes | Ramp Width (in) | 60.0 | No | BlendTrans XSlope (%) | 10.2 |

**Remove & Replace Curb Ramp With Two New Directional Ramps or Equivalent.**

Total Cost: \$ 3200.00
