# Access Compliance Report

## Public Rights-of-Way

### (Curb Ramps)

Intersection ID: 3924	Main Street: COPPERPLATE_RD	Cross Street: WILBURN_PARK_CT	Location: NW
ADA ID: D9BEFD9248A2	Ramp Type: Perp	Initial Pass/Fail: Fail	Overall Compliance: No
Severity Score: 13.75			
Codes/Mitigation Info/Possible Solution		Field Measurements/Component Compliance

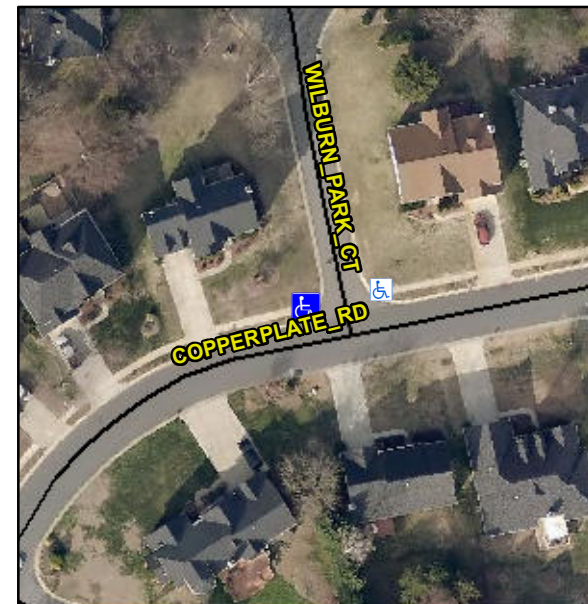
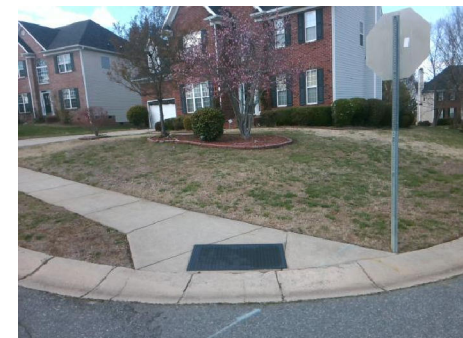
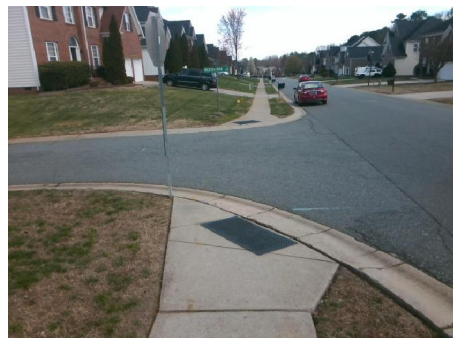
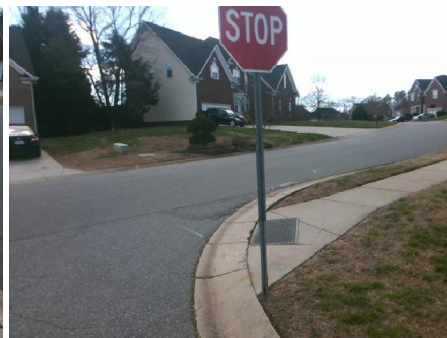
**Not Found, R304.2.2, R304.5.3**

Compliance	Description	Data	Compliance	Description	Data
N/A	Ramp Length (in)	45.0	No	Ramp Slope (%)	11.8
Yes	Ramp Width (in)	170.0	No	Ramp XSlope (%)	4.5
N/A	Flare Type LT	N/A	N/A	Flare Type RT	N/A
N/A	Flare Slope LT (%)	N/A	N/A	Flare Slope RT (%)	N/A
N/A	Flare Traversable LT?	N/A	N/A	Flare Traversable RT?	N/A
N/A	Landing Length (in)	N/A	N/A	DWS Provided?	N/A
N/A	Landing Width (in)	N/A	N/A	DWS Contrast?	N/A
N/A	Landing Slope (%)	N/A	N/A	DWS Length (in)	N/A
N/A	Landing X Slope (%)	N/A	N/A	DWS Full Width?	N/A
N/A	Landing Curb? (Y/N)	N/A	N/A	DWS Offset (in)	N/A
N/A	Shared Landing?	N/A			
N/A	Gutter Ponding?	N/A	N/A	Gutter Slope (%)	N/A
N/A	Gutter Lip Ht (in)	2.0	N/A	Gutter X Slope (%)	N/A
N/A	Painted X Walk1?	No	N/A	Painted X Walk2?	N/A
	X Walk 1 Direction	To E		X Walk 2 Direction	N/A
N/A	X Walk 1 Width (in)	N/A	N/A	X Walk 2 Width (in)	N/A
	X Walk 1 Slope (%)	2.2		X Walk 2 Slope (%)	N/A
	X Walk 1 X Slope (%)	3.3		X Walk 2 X Slope (%)	N/A

N/A	Ramp inside XWalk1?	N/A	N/A	Ramp inside XWalk2?	N/A
	Road Slope (%)	N/A	N/A	Clear Space?	N/A
	Road X Slope (%)	N/A	N/A	Clear Space to XWalk (in)	N/A
N/A	Any Obstructions?	N/A	N/A	Storm Grate/Utility Hazard?	N/A
	Obstruction Type			Storm Grate/Utility Type	
		N/A			N/A
		Yes		Surface Condition? (G/P)	Good

**Remove & Replace Entire Ramp.**
