Access Compliance Report

Public Rights-of-Way

(Curb Ramps)

Intersection ID: 25006	Main Street: BENRIDGE_LN	Cross Street: TRUSCOTT_RD	Location: NW
ADA ID: D9C86FA881BC	Ramp Type: PerpDiag	Initial Pass/Fail: Fail	Overall Compliance: No
Severity Score: 12.5			
Codes/Mitigation Info/Possible Solution		Field Measurements/Component Compliance

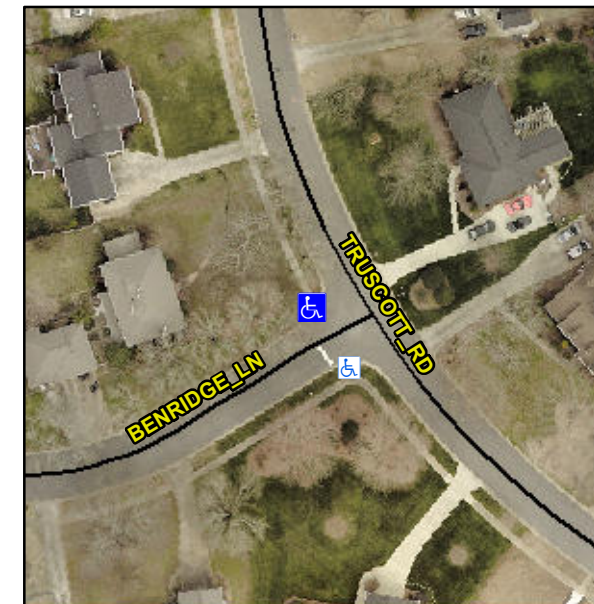
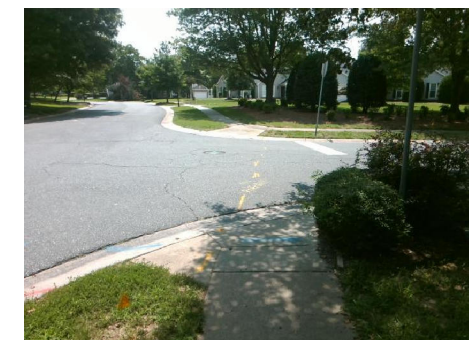
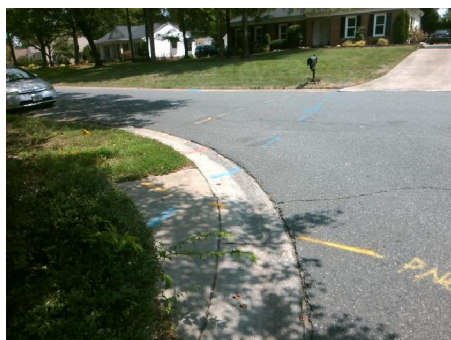
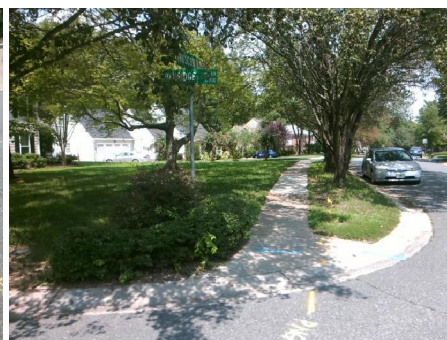
Not Found, R304.5.3

Compliance	Description	Data	Compliance	Description	Data
N/A	Ramp Length (in)	48.0	Yes	Ramp Slope (%)	7.1
Yes	Ramp Width (in)	48.0	No	Ramp XSlope (%)	6.5
N/A	Flare Type LT	N/A	N/A	Flare Type RT	N/A
N/A	Flare Slope LT (%)	N/A	N/A	Flare Slope RT (%)	N/A
N/A	Flare Traversable LT?	N/A	N/A	Flare Traversable RT?	N/A
N/A	Landing Length (in)	N/A	N/A	DWS Provided?	N/A
N/A	Landing Width (in)	N/A	N/A	DWS Contrast?	N/A
N/A	Landing Slope (%)	N/A	N/A	DWS Length (in)	N/A
N/A	Landing X Slope (%)	N/A	N/A	DWS Full Width?	N/A
N/A	Landing Curb? (Y/N)	N/A	N/A	DWS Offset (in)	N/A
N/A	Shared Landing?	N/A			
N/A	Gutter Ponding?	N/A	N/A	Gutter Slope (%)	N/A
N/A	Gutter Lip Ht (in)	N/A	N/A	Gutter X Slope (%)	N/A
N/A	Painted X Walk1?	No	N/A	Painted X Walk2?	No
	X Walk 1 Direction	To S		X Walk 2 Direction	To E
N/A	X Walk 1 Width (in)	N/A	N/A	X Walk 2 Width (in)	N/A
	X Walk 1 Slope (%)	2.7		X Walk 2 Slope (%)	4.4
	X Walk 1 X Slope (%)	4.5		X Walk 2 X Slope (%)	1.6

N/A	Ramp inside XWalk1?	N/A	N/A	Ramp inside XWalk2?	N/A
	Road Slope (%)	0.7	N/A	Clear Space?	N/A
	Road X Slope (%)	7.7	N/A	Clear Space to XWalk (in)	N/A
N/A	Any Obstructions?	N/A	N/A	Storm Grate/Utility Hazard?	N/A
	Obstruction Type			Storm Grate/Utility Type	
		N/A			N/A
		Yes		Surface Condition? (G/P)	Good

Remove & Replace Curb Ramp With Two New Directional Ramps or Equivalent.
