# Access Compliance Report

## Public Rights-of-Way

### (Curb Ramps)

Intersection ID: 6203	Main Street: CRANDON_DR	Cross Street: PEACHWOOD_DR	Location: SE
ADA ID: D9CBE472D837	Ramp Type: BlendTrans1	Initial Pass/Fail: Fail	Overall Compliance: No
Severity Score: 12.5			
Codes/Mitigation Info/Possible Solution		Field Measurements/Component Compliance

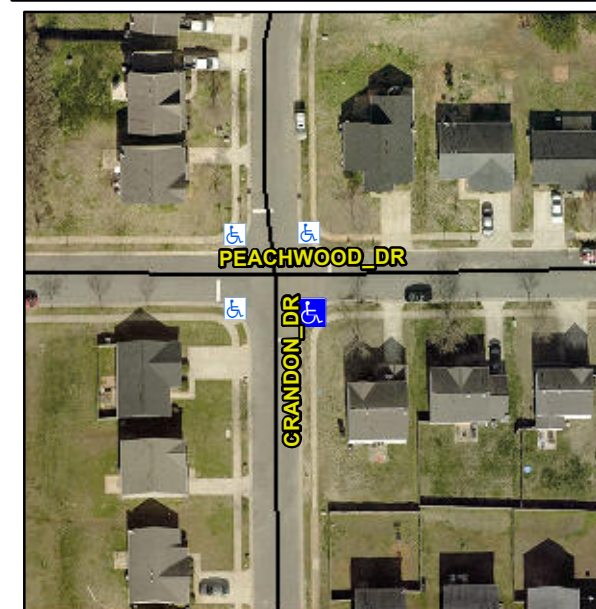
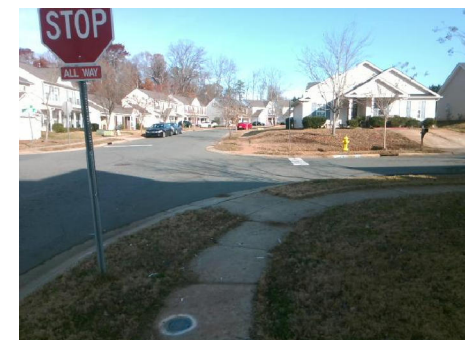
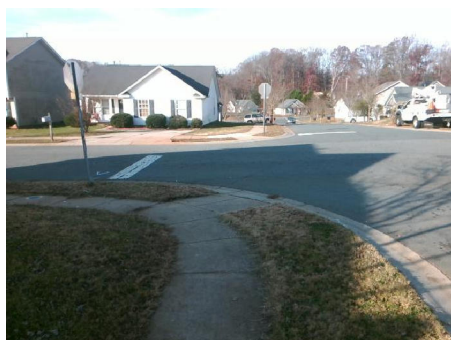
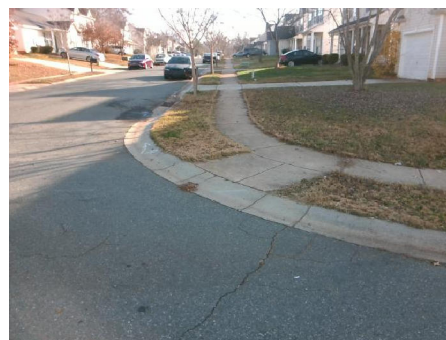
Compliance	Description	Data	Compliance	Description	Data
N/A	Ramp Length (in)	46.0	Yes	BlendTrans Slope (%)	2.2
Yes	Ramp Width (in)	66.0	No	BlendTrans XSlope (%)	6.2
N/A	Flare Type LT	N/A	N/A	Flare Type RT	N/A
N/A	Flare Slope LT (%)	N/A	N/A	Flare Slope RT (%)	N/A
N/A	Flare Traversable LT?	N/A	N/A	Flare Traversable RT?	N/A
N/A	Landing Length (in)	N/A	N/A	DWS Provided?	N/A
N/A	Landing Width (in)	N/A	N/A	DWS Contrast?	N/A
N/A	Landing Slope (%)	N/A	N/A	DWS Length (in)	N/A
N/A	Landing X Slope (%)	N/A	N/A	DWS Full Width?	N/A
N/A	Landing Curb? (Y/N)	N/A	N/A	DWS Offset (in)	N/A
N/A	Shared Landing?	N/A			
N/A	Gutter Ponding?	N/A	N/A	Gutter Slope (%)	N/A
N/A	Gutter Lip Ht (in)	N/A	N/A	Gutter X Slope (%)	N/A
N/A	Painted X Walk1?	No	N/A	Painted X Walk2?	No
	X Walk 1 Direction	To N		X Walk 2 Direction	To W
	X Walk 1 Width (in)	N/A		X Walk 2 Width (in)	N/A
	X Walk 1 Slope (%)	2.7		X Walk 2 Slope (%)	2.0
	X Walk 1 X Slope (%)	2.8		X Walk 2 X Slope (%)	4.5

N/A	Ramp inside XWalk1?	N/A	N/A	Ramp inside XWalk2?	N/A
	Road Slope (%)	4.0		Clear Space?	N/A
	Road X Slope (%)	1.7	N/A	Clear Space to XWalk (in)	N/A
N/A	Any Obstructions?	N/A	N/A	Storm Grate/Utility Hazard?	N/A
	Obstruction Type			Storm Grate/Utility Type	
		N/A			N/A
			Yes	Surface Condition? (G/P)	Good
			No	Curb Slope (%)	15.0

**Remove & Replace Curb Ramp With Two New Directional Ramps or Equivalent.**
