Access Compliance Report

Public Rights-of-Way

(Curb Ramps)

Intersection ID: 3954	Main Street: MOUNTAIN_COVE_DR	Cross Street: OVERLOOK_COVE_RD	Location: SE
ADA ID: D9D9C08A57F4	Ramp Type: Perp	Initial Pass/Fail: Fail	Overall Compliance: No
Severity Score: 46.25			
Codes/Mitigation Info/Possible Solution		Field Measurements/Component Compliance

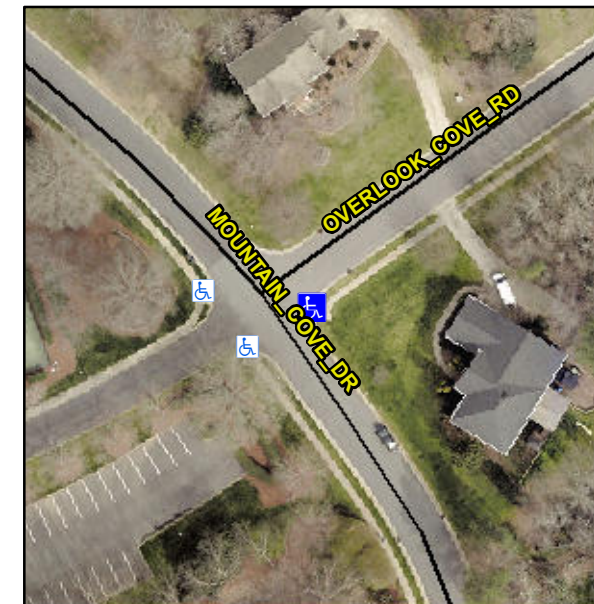
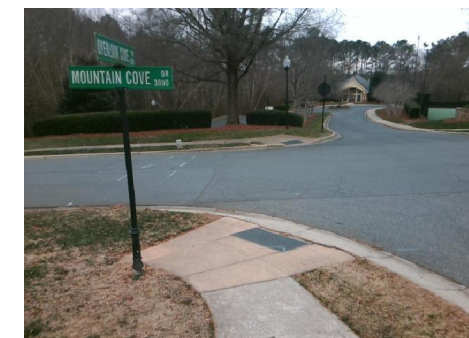
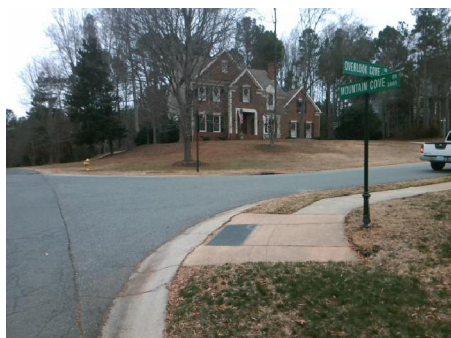
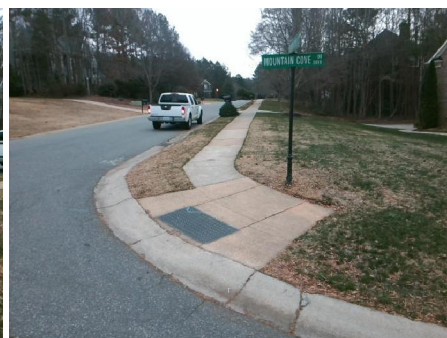
R304.5.1, R304.2.2, R304.5.3

Compliance	Description	Data	Compliance	Description	Data
N/A	Ramp Length (in)	97.0	No	Ramp Slope (%)	8.5
No	Ramp Width (in)	38.0	No	Ramp XSlope (%)	12.4
N/A	Flare Type LT	N/A	N/A	Flare Type RT	N/A
N/A	Flare Slope LT (%)	N/A	N/A	Flare Slope RT (%)	N/A
N/A	Flare Traversable LT?	N/A	N/A	Flare Traversable RT?	N/A
N/A	Landing Length (in)	N/A	N/A	DWS Provided?	N/A
N/A	Landing Width (in)	N/A	N/A	DWS Contrast?	N/A
N/A	Landing Slope (%)	N/A	N/A	DWS Length (in)	N/A
N/A	Landing X Slope (%)	N/A	N/A	DWS Full Width?	N/A
N/A	Landing Curb? (Y/N)	N/A	N/A	DWS Offset (in)	N/A
N/A	Shared Landing?	N/A			
N/A	Gutter Ponding?	N/A	N/A	Gutter Slope (%)	N/A
N/A	Gutter Lip Ht (in)	N/A	N/A	Gutter X Slope (%)	N/A
N/A	Painted X Walk1?	No	N/A	Painted X Walk2?	N/A
	X Walk 1 Direction	To SW		X Walk 2 Direction	N/A
N/A	X Walk 1 Width (in)	N/A	N/A	X Walk 2 Width (in)	N/A
	X Walk 1 Slope (%)	0.5		X Walk 2 Slope (%)	N/A
	X Walk 1 X Slope (%)	6.8		X Walk 2 X Slope (%)	N/A

N/A	Ramp inside XWalk1?	N/A	N/A	Ramp inside XWalk2?	N/A
	Road Slope (%)	N/A	N/A	Clear Space?	N/A
	Road X Slope (%)	N/A	N/A	Clear Space to XWalk (in)	N/A
N/A	Any Obstructions?	N/A	N/A	Storm Grate/Utility Hazard?	N/A
	Obstruction Type			Storm Grate/Utility Type	
		N/A			N/A
			Yes	Surface Condition? (G/P)	Good

Possible Solutions:

Remove & Replace Entire Ramp.

Total Cost: \$ 1850.00
