Access Compliance Report

Public Rights-of-Way

(Curb Ramps)

Intersection ID: 46685	Main Street: JEWELFLOWER_RD	Cross Street: GOLDFIELDS_DR	Location: SW
ADA ID: D9E41E9899A0	Ramp Type: Perp	Initial Pass/Fail: Fail	Overall Compliance: No
Severity Score: 12.5			
Codes/Mitigation Info/Possible Solution		Field Measurements/Component Compliance

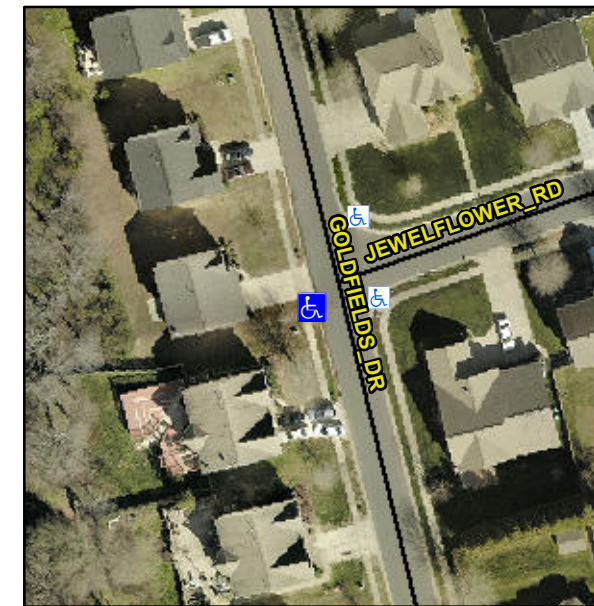
Not Found, R304.2.2

Compliance	Description	Data	Compliance	Description	Data
N/A	Ramp Length (in)	46.5	No	Ramp Slope (%)	10.2
Yes	Ramp Width (in)	48.0	Yes	Ramp XSlope (%)	1.3
N/A	Flare Type LT	N/A	N/A	Flare Type RT	N/A
N/A	Flare Slope LT (%)	N/A	N/A	Flare Slope RT (%)	N/A
N/A	Flare Traversable LT?	N/A	N/A	Flare Traversable RT?	N/A
N/A	Landing Length (in)	N/A	N/A	DWS Provided?	N/A
N/A	Landing Width (in)	N/A	N/A	DWS Contrast?	N/A
N/A	Landing Slope (%)	N/A	N/A	DWS Length (in)	N/A
N/A	Landing X Slope (%)	N/A	N/A	DWS Full Width?	N/A
N/A	Landing Curb? (Y/N)	N/A	N/A	DWS Offset (in)	N/A
N/A	Shared Landing?	N/A			
N/A	Gutter Ponding?	N/A	N/A	Gutter Slope (%)	N/A
N/A	Gutter Lip Ht (in)	N/A	N/A	Gutter X Slope (%)	N/A
N/A	Painted X Walk1?	No	N/A	Painted X Walk2?	N/A
	X Walk 1 Direction	To E		X Walk 2 Direction	N/A
N/A	X Walk 1 Width (in)	N/A	N/A	X Walk 2 Width (in)	N/A
	X Walk 1 Slope (%)	3.1		X Walk 2 Slope (%)	N/A
	X Walk 1 X Slope (%)	0.8		X Walk 2 X Slope (%)	N/A

N/A	Ramp inside XWalk1?	N/A	N/A	Ramp inside XWalk2?	N/A
	Road Slope (%)	N/A	N/A	Clear Space?	N/A
	Road X Slope (%)	N/A	N/A	Clear Space to XWalk (in)	N/A
N/A	Any Obstructions?	N/A	N/A	Storm Grate/Utility Hazard?	N/A
	Obstruction Type			Storm Grate/Utility Type	
		N/A			N/A
			Yes	Surface Condition? (G/P)	Good

Remove & Replace Entire Ramp.
