Access Compliance Report

Public Rights-of-Way

(Curb Ramps)

Intersection ID: 53339	Main Street: NORTHLAKE CENTRE PY	Cross Street: CALHOUN ST	Location: NE
ADA ID: DA002E5F00DB	Ramp Type: Perp	Initial Pass/Fail: Fail	Overall Compliance: No
Severity Score: 10			
Codes/Mitigation Info/Possible Solution		Field Measurements/Component Compliance

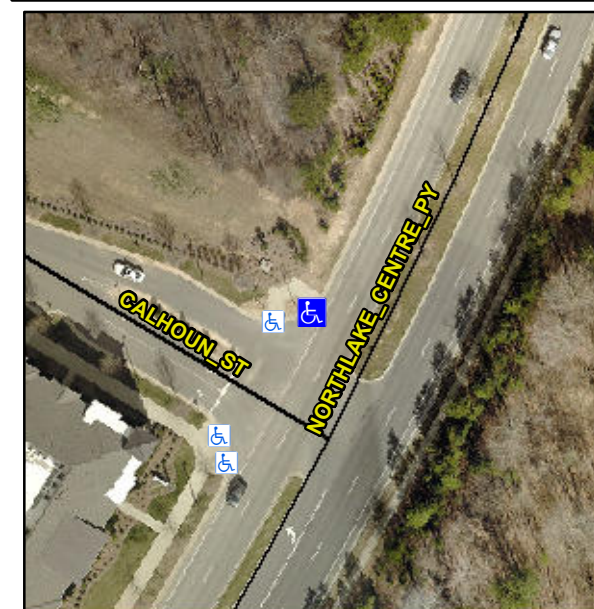
Compliance	Description	Data	Compliance	Description	Data
N/A	Ramp Length (in)	96.0	Yes	Ramp Slope (%)	5.9
No	Ramp Width (in)	46.0	No	Ramp XSlope (%)	2.2
N/A	Flare Type LT	N/A	N/A	Flare Type RT	N/A
N/A	Flare Slope LT (%)	N/A	N/A	Flare Slope RT (%)	N/A
N/A	Flare Traversable LT?	N/A	N/A	Flare Traversable RT?	N/A
N/A	Landing Length (in)	N/A	N/A	DWS Provided?	N/A
N/A	Landing Width (in)	N/A	N/A	DWS Contrast?	N/A
N/A	Landing Slope (%)	N/A	N/A	DWS Length (in)	N/A
N/A	Landing X Slope (%)	N/A	N/A	DWS Full Width?	N/A
N/A	Landing Curb? (Y/N)	N/A	N/A	DWS Offset (in)	N/A
N/A	Shared Landing?	N/A			
N/A	Gutter Ponding?	N/A	N/A	Gutter Slope (%)	N/A
N/A	Gutter Lip Ht (in)	N/A	N/A	Gutter X Slope (%)	N/A
N/A	Painted X Walk1?	No	N/A	Painted X Walk2?	N/A
	X Walk 1 Direction	To SE		X Walk 2 Direction	N/A
N/A	X Walk 1 Width (in)	N/A	N/A	X Walk 2 Width (in)	N/A
	X Walk 1 Slope (%)	1.7		X Walk 2 Slope (%)	N/A
	X Walk 1 X Slope (%)	0.7		X Walk 2 X Slope (%)	N/A

N/A	Ramp inside XWalk1?	N/A	N/A	Ramp inside XWalk2?	N/A
	Road Slope (%)	0.7	N/A	Clear Space?	N/A
	Road X Slope (%)	1.7	N/A	Clear Space to XWalk (in)	N/A
N/A	Any Obstructions?	N/A	N/A	Storm Grate/Utility Hazard?	N/A
	Obstruction Type			Storm Grate/Utility Type	
		N/A			N/A
			Yes	Surface Condition? (G/P)	Good

Possible Solutions:

Remove & Replace Entire Ramp.

R304.5.1, R304.5.3
