Access Compliance Report Public Rights-of-Way (Curb Ramps)

Intersection ID: N/A Main Street: MUNSEE ST Cross Street: W SUGAR CREEK RD Location: SE Ramp Type: Combination2Diag Initial Pass/Fail: Fail **Overall Compliance: No Severity Score:** 0 **ADA ID: DA07EB40533C**

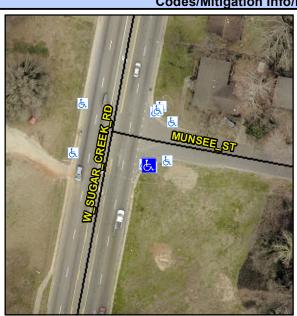
Compliance Description		Data	Compl	iance	Description	
N/A	Ramp Length LT (in)	70.0	N/A	Ramp	Length RT (in)	
No	Ramp Width LT (in)	35.5	No	Ramp	Width RT (in)	
Yes	Ramp Slope LT (%)	3.2	Yes	Ramp	Slope RT (%)	
Yes	Ramp XSlope LT (%)	8.0	No	Ramp	XSlope RT (%)	
N/A	Ramp Length (in)	25.0	Yes	Ramp	Slope (%)	
Yes	Ramp Width (in)	48.0	Yes	Ramp	XSlope (%)	
N/A	Flare Type LT	N/A	N/A	Flare	Type RT	
N/A	Flare Slope LT (%)	N/A	N/A	Flare	Slope RT (%)	
N/A	Flare Traversable LT?	N/A	N/A	Flare	Traversable RT?	
N/A	Landing Length (in)	N/A	N/A	DWS	DWS Provided?	
N/A	Landing Width (in)	N/A	N/A	DWS	DWS Contrast?	
N/A	Landing Slope (%)	N/A	N/A	DWS	Length (in)	
N/A	Landing X Slope (%)	N/A	N/A	DWS	Full Width?	
N/A	Landing Curb? (Y/N)	N/A	N/A	DWS	Offset (in)	
N/A	Shared Landing?	N/A				
N/A	Gutter Ponding?	N/A	N/A	Gutte	r Slope (%)	
N/A	Gutter Lip Ht (in)	N/A	N/A	Gutte	r X Slope (%)	
N/A	Painted X Walk1?	No	N/A	Paint	ed X Walk2?	
	X Walk 1 Direction	To N		X Wa	lk 2 Direction

N/A	Any Obstruction?	N/A
	Obstruction Type	
		N/A
N/A	Storm Grate/Utility Hazard?	N/A
	Storm Grate/Utility Type	
		N/A
Yes	Surface Condition? (G/P)	Good
	Curb Slope (%)	19.4

StopSign **MUNSEE ST** None W SUGAR CREEK RD Possible Solutions: Remove & Replace Curb Ramp With Two New Directional Ramps or Equivalent. Remove & Replace Sidewalk. Surveyor Notes: N/A PROW/ADA: Not Found, R304.5.1, R304.5.3
