# Access Compliance Report

## Public Rights-of-Way

### (Curb Ramps)

| Intersection ID: 13178 | Main Street: CENTRAL_AV | Cross Street: ST_JULIEN_ST | Location: SE |

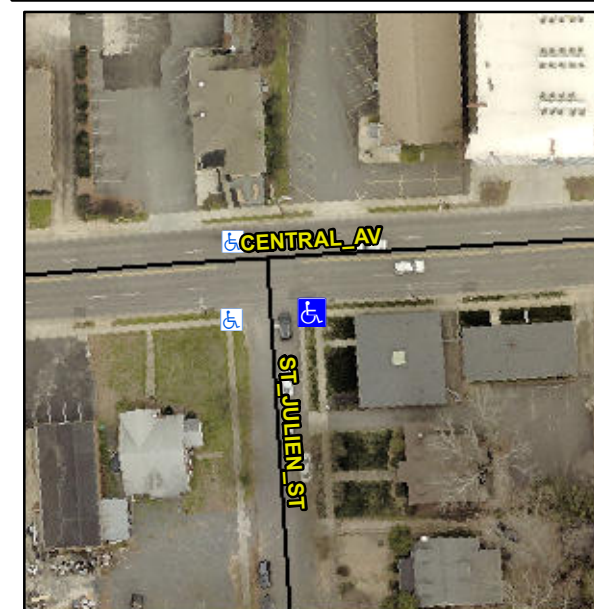
**Not Found, R304.2.1, R304.2.2-Perp, R304.3.2-Para, R305.1.4, R305.2**

| Compliance | Description | Data | Compliance | Description | Data |
|---|---|---|---|---|---|
| No | Landing Width (in) | 46.0 | Yes | DWS Contrast? | Yes |
| No | Landing Slope (%) | 2.7 | Yes | DWS Length (in) | 24.0 |
| Yes | Landing X Slope (%) | 1.6 | No | DWS Full Width? | No |
| N/A | Landing Curb? (Y/N) | No | No | DWS Offset (in) | 5.5 |

**Remove & Replace Curb Ramp With Two New Directional Ramps or Equivalent.**

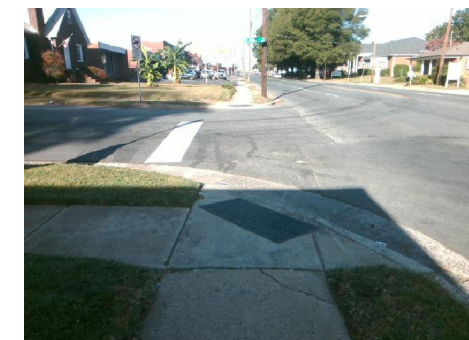
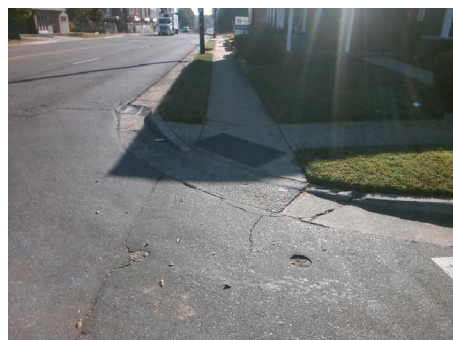
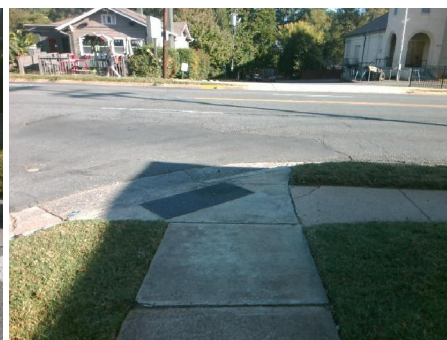
| ADA ID: DA10520A97E2 | Ramp Type: PerpDiag | Initial Pass/Fail: Pass | Overall Compliance: No |
| Severity Score: 2.5 | | | |
