# Access Compliance Report

## Public Rights-of-Way

### (Curb Ramps)

Intersection ID: 14294	Main Street: EAST_BV	Cross Street: EUCLID_AV	Location: SW
ADA ID: DA18B0DFA839	Ramp Type: Directional1	Initial Pass/Fail: Pass	Overall Compliance: No
		Severity Score: 0

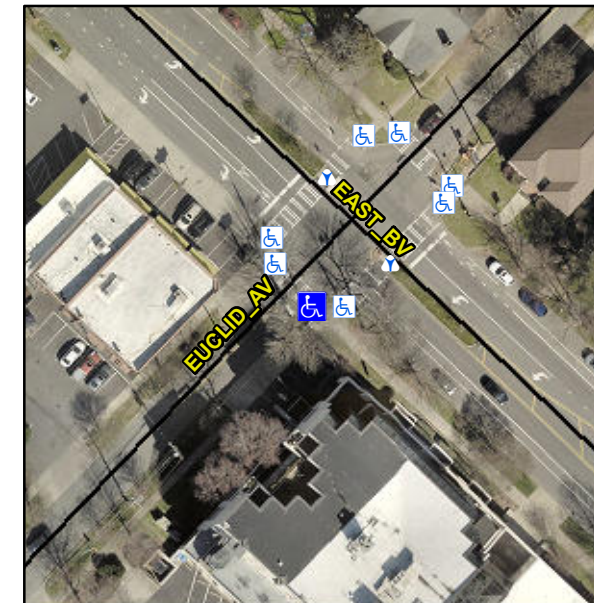
**Not Found, R304.2.2-Perp, R304.3.2-Para, R304.5.2**

Compliance	Description	Data	Compliance	Description	Data
N/A	Ramp Length (in)	63.0	No	Grade Break?	No
Yes	Ramp Width (in)	61.0	N/A	Grade Break Slope (%)	6.5
Yes	Ramp Slope (%)	6.6	N/A	Grade Break XSlope (%)	0.3
Yes	Ramp XSlope (%)	1.0			
Yes	Flare Type LT	N/A	Yes	Flare Type RT	N/A
N/A	Flare Slope LT (%)	N/A	N/A	Flare Slope RT (%)	N/A
N/A	Flare Traversable LT?	No	N/A	Flare Traversable RT?	No
Yes	Landing Length (in)	48.0	Yes	DWS Provided?	Yes
Yes	Landing Width (in)	61.0	Yes	DWS Contrast?	Yes
No	Landing Slope (%)	3.4	Yes	DWS Length (in)	24.0
Yes	Landing X Slope (%)	1.4	Yes	DWS Full Width?	Yes
N/A	Landing Curb? (Y/N)	N/A	Yes	DWS Offset LT (in)	0.0
N/A	Shared Landing?	No	Yes	DWS Offset RT (in)	16.0
Yes	Gutter Ponding?	No	Yes	Gutter Slope (%)	2.9
Yes	Gutter Lip Ht (in)	0.0	Yes	Gutter X Slope (%)	4.3
N/A	Painted X Walk1?	Yes		Road Slope (%)	5.2
	X Walk 1 Direction	To NW		Road X Slope (%)	4.8
	X Walk 1 Width (in)	112.0		Clear Space?	Yes

X Walk 1 Slope (%)	5.2	N/A	Clear Space to XWalk (in)	N/A
	X Walk 1 X Slope (%)	4.8	Yes	Storm Grate/Utility Hazard?	No
Yes	Ramp inside XWalk1?	Yes		Storm Grate/Utility Type	
Yes	Any Obstructions?	No			N/A
	Obstruction Type		Yes	Surface Condition? (G/P)	Good
			N/A	Curb Slope (%)	10.4

**Remove & Replace Entire Ramp.**
