Access Compliance Report

Public Rights-of-Way

(Curb Ramps)

Intersection ID: 47684	Main Street: NEWFIELD_ST	Cross Street: LEWISBURG_ST	Location:	N
ADA ID: DA1FA0BF5912	Ramp Type: Perp	Initial Pass/Fail: Fail	Overall Compliance: No	Severity Score: 8.75
Codes/Mitigation Info/Possible Solution		Field Measurements/Component Compliance

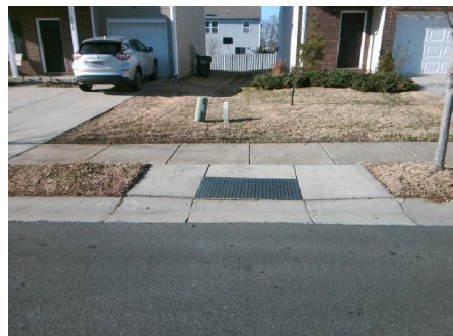
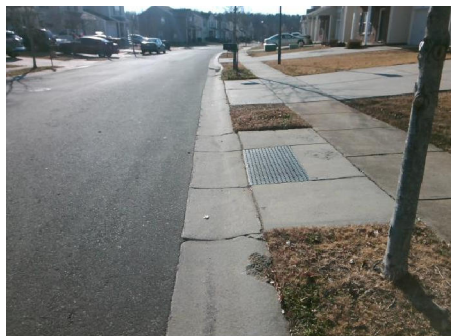
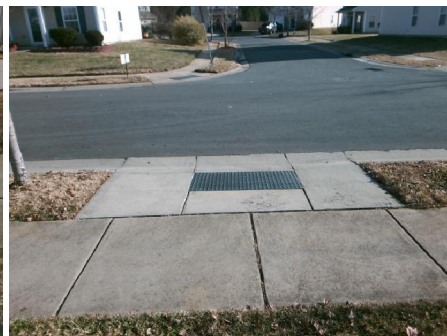
Not Found, R304.5.1

Compliance	Description	Data	Compliance	Description	Data
N/A	Ramp Length (in)	47.0	Yes	Ramp Slope (%)	5.6
No	Ramp Width (in)	47.0	Yes	Ramp XSlope (%)	0.9
N/A	Flare Type LT	N/A	N/A	Flare Type RT	N/A
N/A	Flare Slope LT (%)	N/A	N/A	Flare Slope RT (%)	N/A
N/A	Flare Traversable LT?	N/A	N/A	Flare Traversable RT?	N/A
N/A	Landing Length (in)	N/A	N/A	DWS Provided?	N/A
N/A	Landing Width (in)	N/A	N/A	DWS Contrast?	N/A
N/A	Landing Slope (%)	N/A	N/A	DWS Length (in)	N/A
N/A	Landing X Slope (%)	N/A	N/A	DWS Full Width?	N/A
N/A	Landing Curb? (Y/N)	N/A	N/A	DWS Offset (in)	N/A
N/A	Shared Landing?	N/A			
N/A	Gutter Ponding?	N/A	N/A	Gutter Slope (%)	N/A
N/A	Gutter Lip Ht (in)	N/A	N/A	Gutter X Slope (%)	N/A
N/A	Painted X Walk1?	No	N/A	Painted X Walk2?	N/A
	X Walk 1 Direction	To SE		X Walk 2 Direction	N/A
N/A	X Walk 1 Width (in)	N/A	N/A	X Walk 2 Width (in)	N/A
	X Walk 1 Slope (%)	2.1		X Walk 2 Slope (%)	N/A
	X Walk 1 X Slope (%)	0.6		X Walk 2 X Slope (%)	N/A

N/A	Ramp inside XWalk1?	N/A	N/A	Ramp inside XWalk2?	N/A
	Road Slope (%)	N/A	N/A	Clear Space?	N/A
	Road X Slope (%)	N/A	N/A	Clear Space to XWalk (in)	N/A
N/A	Any Obstructions?	N/A	N/A	Storm Grate/Utility Hazard?	N/A
	Obstruction Type			Storm Grate/Utility Type	
		N/A			N/A
			Yes	Surface Condition? (G/P)	Good

Remove & Replace Entire Ramp.
