Access Compliance Report

Public Rights-of-Way

(Curb Ramps)

Intersection ID: 10025412	Main Street: E_CARSON_BV	Cross Street: N/A	Location: E
ADA ID: DA2261380488	Ramp Type: Perp	Initial Pass/Fail: Fail	Overall Compliance: No
Severity Score: 12.5			
Codes/Mitigation Info/Possible Solution		Field Measurements/Component Compliance

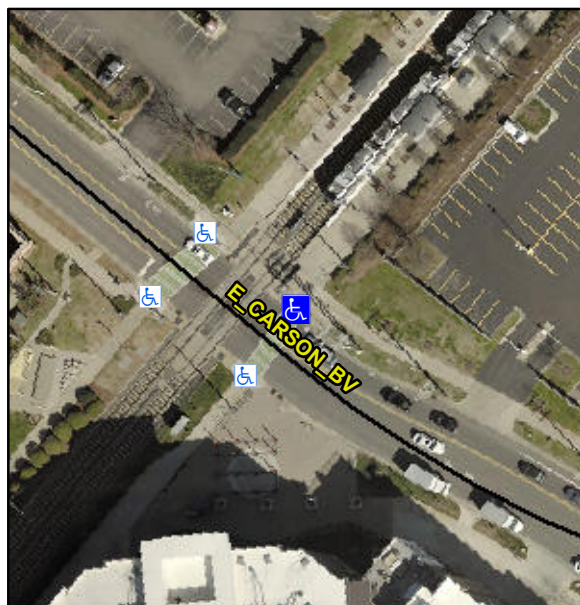
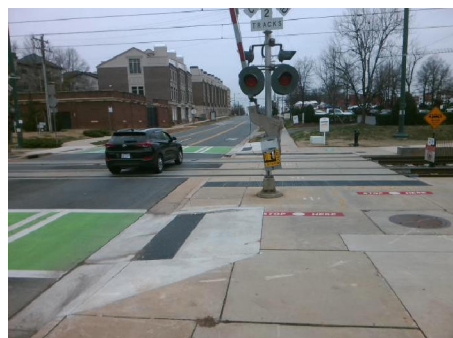
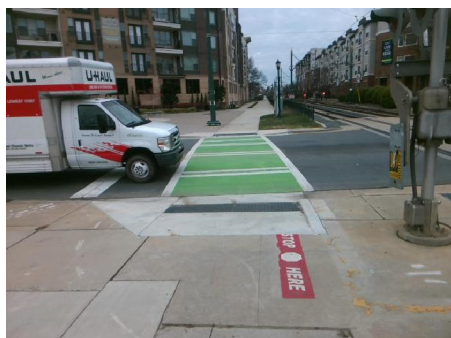
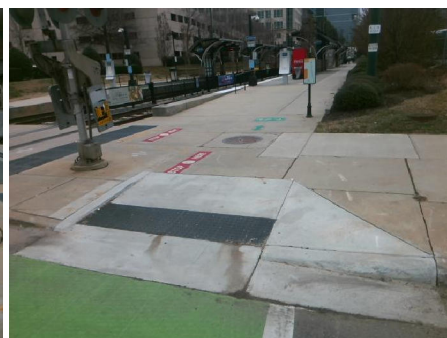
Not Found, R304.2.2

Compliance	Description	Data	Compliance	Description	Data
N/A	Ramp Length (in)	72.0	No	Ramp Slope (%)	11.4
Yes	Ramp Width (in)	96.0	Yes	Ramp XSlope (%)	0.6
N/A	Flare Type LT	N/A	N/A	Flare Type RT	N/A
N/A	Flare Slope LT (%)	N/A	N/A	Flare Slope RT (%)	N/A
N/A	Flare Traversable LT?	N/A	N/A	Flare Traversable RT?	N/A
N/A	Landing Length (in)	N/A	N/A	DWS Provided?	N/A
N/A	Landing Width (in)	N/A	N/A	DWS Contrast?	N/A
N/A	Landing Slope (%)	N/A	N/A	DWS Length (in)	N/A
N/A	Landing X Slope (%)	N/A	N/A	DWS Full Width?	N/A
N/A	Landing Curb? (Y/N)	N/A	N/A	DWS Offset (in)	N/A
N/A	Shared Landing?	N/A			
N/A	Gutter Ponding?	N/A	N/A	Gutter Slope (%)	N/A
N/A	Gutter Lip Ht (in)	N/A	N/A	Gutter X Slope (%)	N/A
N/A	Painted X Walk1?	Yes	N/A	Painted X Walk2?	N/A
	X Walk 1 Direction	To SW		X Walk 2 Direction	N/A
N/A	X Walk 1 Width (in)	113.0	N/A	X Walk 2 Width (in)	N/A
	X Walk 1 Slope (%)	3.9		X Walk 2 Slope (%)	N/A
	X Walk 1 X Slope (%)	2.3		X Walk 2 X Slope (%)	N/A

N/A	Ramp inside XWalk1?	Yes	N/A	Ramp inside XWalk2?	N/A
	Road Slope (%)	N/A	N/A	Clear Space?	N/A
	Road X Slope (%)	N/A	N/A	Clear Space to XWalk (in)	N/A
N/A	Any Obstructions?	N/A	N/A	Storm Grate/Utility Hazard?	N/A
	Obstruction Type			Storm Grate/Utility Type	
		N/A			N/A
			Yes	Surface Condition? (G/P)	Good

Possible Solutions:

Remove & Replace Entire Ramp.
