Access Compliance Report

Public Rights-of-Way

(Curb Ramps)

Intersection ID: 23663	Main Street: S_TRYON_ST	Cross Street: ERWIN_RD	Location: NW
ADA ID: DA246B262E62	Ramp Type: Perp	Initial Pass/Fail: Fail	Overall Compliance: No
			Severity Score: 13.75

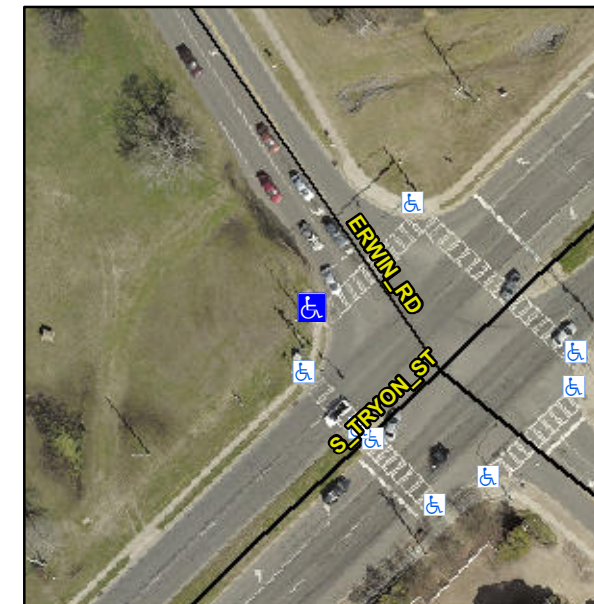
Not Found, R304.2.2, R304.5.3

Compliance	Description	Data	Compliance	Description	Data
N/A	Ramp Length (in)	90.0	No	Ramp Slope (%)	8.5
Yes	Ramp Width (in)	48.0	No	Ramp XSlope (%)	2.3
N/A	Flare Type LT	N/A	N/A	Flare Type RT	N/A
N/A	Flare Slope LT (%)	N/A	N/A	Flare Slope RT (%)	N/A
N/A	Flare Traversable LT?	N/A	N/A	Flare Traversable RT?	N/A
N/A	Landing Length (in)	N/A	N/A	DWS Provided?	N/A
N/A	Landing Width (in)	N/A	N/A	DWS Contrast?	N/A
N/A	Landing Slope (%)	N/A	N/A	DWS Length (in)	N/A
N/A	Landing X Slope (%)	N/A	N/A	DWS Full Width?	N/A
N/A	Landing Curb? (Y/N)	N/A	N/A	DWS Offset (in)	N/A
N/A	Shared Landing?	N/A			
N/A	Gutter Ponding?	N/A	N/A	Gutter Slope (%)	N/A
N/A	Gutter Lip Ht (in)	N/A	N/A	Gutter X Slope (%)	N/A
N/A	Painted X Walk1?	Yes	N/A	Painted X Walk2?	N/A
	X Walk 1 Direction	To NE		X Walk 2 Direction	N/A
N/A	X Walk 1 Width (in)	120.0	N/A	X Walk 2 Width (in)	N/A
	X Walk 1 Slope (%)	2.5		X Walk 2 Slope (%)	N/A
	X Walk 1 X Slope (%)	0.4		X Walk 2 X Slope (%)	N/A

N/A	Ramp inside XWalk1?	Yes	N/A	Ramp inside XWalk2?	N/A
	Road Slope (%)	N/A	N/A	Clear Space?	N/A
	Road X Slope (%)	N/A	N/A	Clear Space to XWalk (in)	N/A
N/A	Any Obstructions?	N/A	N/A	Storm Grate/Utility Hazard?	N/A
	Obstruction Type			Storm Grate/Utility Type	
		N/A			N/A
			Yes	Surface Condition? (G/P)	Good

Remove & Replace Entire Ramp.
