Access Compliance Report

Public Rights-of-Way

(Curb Ramps)

Intersection ID: 45835	Main Street: CHRISTENBURY_HILLS_LN	Cross Street: KELDEN_WALKER_LN	Location: SE
ADA ID: DA2BA0A74FF5	Ramp Type: PerpDiag	Initial Pass/Fail: Fail	Overall Compliance: No
Severity Score: 85			
Codes/Mitigation Info/Possible Solution		Field Measurements/Component Compliance

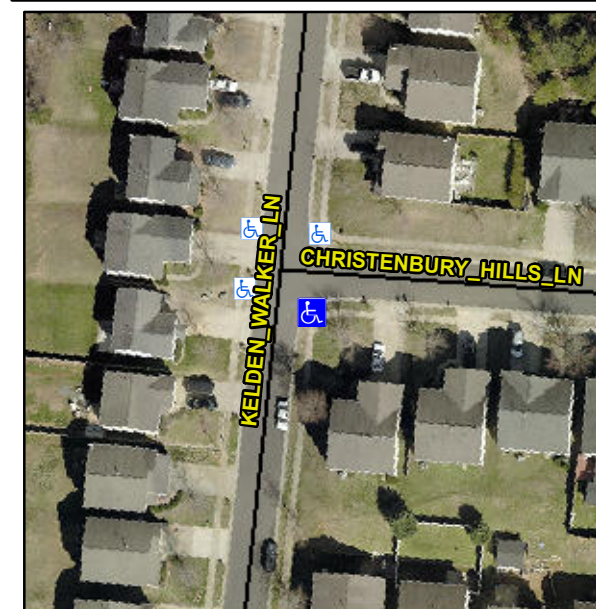
Not Found, R304.5.1, R304.2.2, R304.5.3

Compliance	Description	Data	Compliance	Description	Data
N/A	Ramp Length (in)	46.0	No	Ramp Slope (%)	12.5
No	Ramp Width (in)	30.5	No	Ramp XSlope (%)	15.0
N/A	Flare Type LT	N/A	N/A	Flare Type RT	N/A
N/A	Flare Slope LT (%)	N/A	N/A	Flare Slope RT (%)	N/A
N/A	Flare Traversable LT?	N/A	N/A	Flare Traversable RT?	N/A
N/A	Landing Length (in)	N/A	N/A	DWS Provided?	N/A
N/A	Landing Width (in)	N/A	N/A	DWS Contrast?	N/A
N/A	Landing Slope (%)	N/A	N/A	DWS Length (in)	N/A
N/A	Landing X Slope (%)	N/A	N/A	DWS Full Width?	N/A
N/A	Landing Curb? (Y/N)	N/A	N/A	DWS Offset (in)	N/A
N/A	Shared Landing?	N/A			
N/A	Gutter Ponding?	N/A	N/A	Gutter Slope (%)	N/A
N/A	Gutter Lip Ht (in)	N/A	N/A	Gutter X Slope (%)	N/A
N/A	Painted X Walk1?	No	N/A	Painted X Walk2?	No
	X Walk 1 Direction	To N		X Walk 2 Direction	To NW
N/A	X Walk 1 Width (in)	N/A	N/A	X Walk 2 Width (in)	N/A
	X Walk 1 Slope (%)	7.6		X Walk 2 Slope (%)	4.3
	X Walk 1 X Slope (%)	8.0		X Walk 2 X Slope (%)	9.4

N/A	Ramp inside XWalk1?	N/A	N/A	Ramp inside XWalk2?	N/A
	Road Slope (%)	11.9	N/A	Clear Space?	N/A
	Road X Slope (%)	1.9	N/A	Clear Space to XWalk (in)	N/A
N/A	Any Obstructions?	N/A	N/A	Storm Grate/Utility Hazard?	N/A
	Obstruction Type			Storm Grate/Utility Type	
		N/A			N/A
			Yes	Surface Condition? (G/P)	Good

Remove & Replace Curb Ramp With Two New Directional Ramps or Equivalent.
