Access Compliance Report

Public Rights-of-Way

(Curb Ramps)

Intersection ID: 29671	Main Street: BANNINGTON_RD	Cross Street: TOM_CASTAIN_LN	Location: S
ADA ID: DA3471527054	Ramp Type: BlendTrans1	Initial Pass/Fail: Fail	Overall Compliance: No
Severity Score: 8.75			
Codes/Mitigation Info/Possible Solution		Field Measurements/Component Compliance

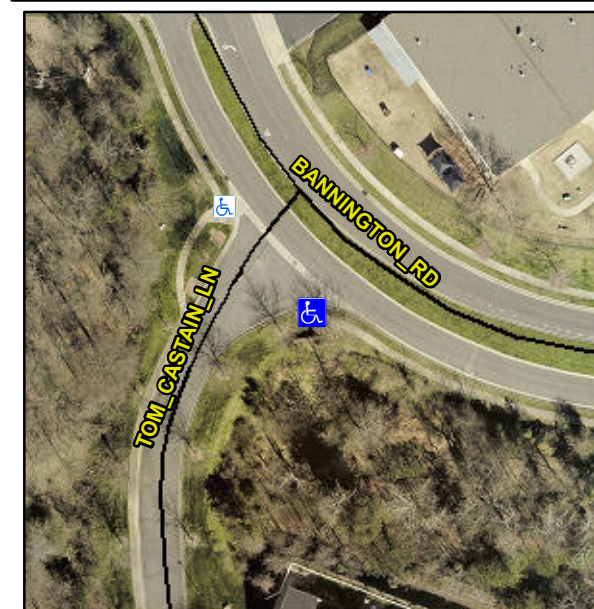
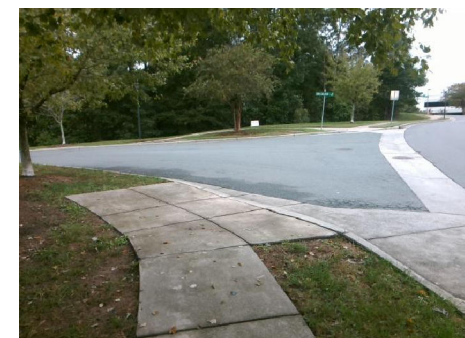
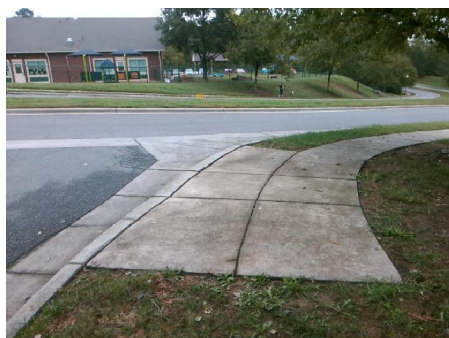
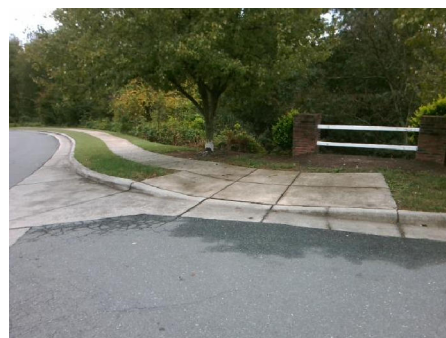
Compliance	Description	Data	Compliance	Description	Data
N/A	Ramp Length (in)	45.0	Yes	BlendTrans Slope (%)	1.0
No	Ramp Width (in)	45.0	Yes	BlendTrans XSlope (%)	1.4
N/A	Flare Type LT	N/A	N/A	Flare Type RT	N/A
N/A	Flare Slope LT (%)	N/A	N/A	Flare Slope RT (%)	N/A
N/A	Flare Traversable LT?	N/A	N/A	Flare Traversable RT?	N/A
N/A	Landing Length (in)	N/A	N/A	DWS Provided?	N/A
N/A	Landing Width (in)	N/A	N/A	DWS Contrast?	N/A
N/A	Landing Slope (%)	N/A	N/A	DWS Length (in)	N/A
N/A	Landing X Slope (%)	N/A	N/A	DWS Full Width?	N/A
N/A	Landing Curb? (Y/N)	N/A	N/A	DWS Offset (in)	N/A
N/A	Shared Landing?	N/A			
N/A	Gutter Ponding?	N/A	N/A	Gutter Slope (%)	N/A
N/A	Gutter Lip Ht (in)	N/A	N/A	Gutter X Slope (%)	N/A
N/A	Painted X Walk1?	No	N/A	Painted X Walk2?	N/A
	X Walk 1 Direction	To NW		X Walk 2 Direction	N/A
	X Walk 1 Width (in)	N/A		X Walk 2 Width (in)	N/A
	X Walk 1 Slope (%)	4.3		X Walk 2 Slope (%)	N/A
	X Walk 1 X Slope (%)	0.4		X Walk 2 X Slope (%)	N/A

N/A	Ramp inside XWalk1?	N/A	N/A	Ramp inside XWalk2?	N/A
	Road Slope (%)	0.4		Clear Space?	N/A
	Road X Slope (%)	4.3	N/A	Clear Space to XWalk (in)	N/A
N/A	Any Obstructions?	N/A	N/A	Storm Grate/Utility Hazard?	N/A
	Obstruction Type			Storm Grate/Utility Type	
		N/A			N/A
			Yes	Surface Condition? (G/P)	Good
			N/A	Curb Slope (%)	2.7

Possible Solutions:

Remove & Replace Curb Ramp With Two New Directional Ramps or Equivalent.

R304.5.1
