Access Compliance Report

Public Rights-of-Way

(Curb Ramps)

Intersection ID: 17156	Main Street: BRIABEND_DR	Cross Street: FIRWOOD_LN	Location: SW
ADA ID: DA36E3EDFE37	Ramp Type: ParaDiag	Initial Pass/Fail: Fail	Overall Compliance: No
Codes/Mitigation Info/Possible Solution		Field Measurements/Component Compliance	
Severity Score: 13.75

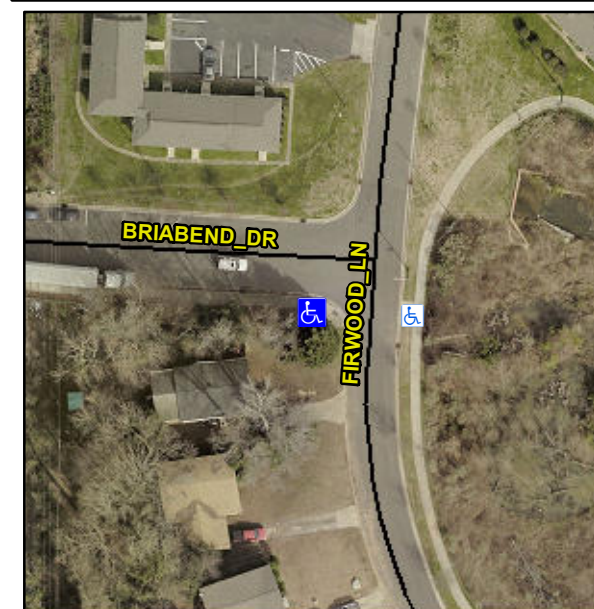
CURB GAP 1.0

Compliance	Description	Data	Compliance	Description	Data
N/A	Ramp Length LT (in)	45.0	N/A	Ramp Length RT (in)	57.0
Yes	Ramp Width LT (in)	72.0	Yes	Ramp Width RT (in)	72.0
Yes	Ramp Slope LT (%)	5.6	No	Ramp Slope RT (%)	9.0
Yes	Ramp XSlope LT (%)	1.2	No	Ramp XSlope RT (%)	2.8
N/A	Landing Length (in)	N/A	N/A	DWS Provided?	N/A
N/A	Landing Width (in)	N/A	N/A	DWS Contrast?	N/A
N/A	Landing Slope (%)	N/A	N/A	DWS Length (in)	N/A
N/A	Landing X Slope (%)	N/A	N/A	DWS Full Width?	N/A
N/A	Landing Curb? (Y/N)	N/A	N/A	DWS Offset (in)	N/A
N/A	Shared Landing?	N/A			
N/A	Gutter Ponding?	N/A	N/A	Gutter Slope (%)	N/A
N/A	Gutter Lip Ht (in)	N/A	N/A	Gutter X Slope (%)	N/A
N/A	Painted X Walk1?	No	N/A	Painted X Walk2?	No
	X Walk 1 Direction	To E		X Walk 2 Direction	To N
N/A	X Walk 1 Width (in)	N/A	N/A	X Walk 2 Width (in)	N/A
	X Walk 1 Slope (%)	3.4		X Walk 2 Slope (%)	1.1
	X Walk 1 X Slope (%)	0.1		X Walk 2 X Slope (%)	0.8
N/A	Ramp inside XWalk1?	N/A	N/A	Ramp inside XWalk2?	N/A

Road Slope (%)	1.4	N/A	Clear Space?	N/A
	Road X Slope (%)	1.5	N/A	Clear Space to XWalk (in)	N/A
N/A	Any Obstructions?	N/A	N/A	Storm Grate/Utility Hazard?	N/A
	Obstruction Type			Storm Grate/Utility Type	
		N/A			N/A
			Yes	Surface Condition? (G/P)	Good
			N/A	Curb Slope (%)	15.1

Possible Solutions:

Remove & Replace Curb Ramp With Two New Directional Ramps or Equivalent.

R304.3.2, R304.5.3

Total Cost: \$ 3200.00
