# Access Compliance Report

## Public Rights-of-Way

### (Curb Ramps)

Intersection ID: N/A	Main Street: TRYON_ST	Cross Street: PARKAIRE_LN	Location: SW
ADA ID: DA40E6AADD13	Ramp Type: Directional	Initial Pass/Fail: Fail	Overall Compliance: No
			Severity Score: 21.25

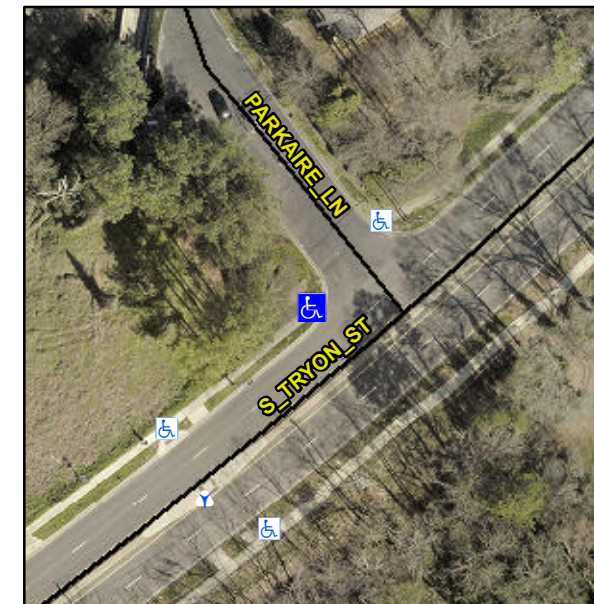
Compliance	Description	Data	Compliance	Description	Data
N/A	Ramp Length (in)	53.0	N/A	Grade Break?	N/A
No	Ramp Width (in)	46.0	N/A	Grade Break Slope (%)	0.0
No	Ramp Slope (%)	8.6	N/A	Grade Break XSlope (%)	0.0
Yes	Ramp XSlope (%)	1.7			
N/A	Flare Type LT	N/A	N/A	Flare Type RT	N/A
N/A	Flare Slope LT (%)	N/A	N/A	Flare Slope RT (%)	0.0
N/A	Flare Traversable LT?	N/A	N/A	Flare Traversable RT?	N/A
N/A	Landing Length (in)	0.0	N/A	DWS Provided?	N/A
N/A	Landing Width (in)	0.0	N/A	DWS Contrast?	N/A
N/A	Landing Slope (%)	0.0	N/A	DWS Length (in)	N/A
N/A	Landing X Slope (%)	0.0	N/A	DWS Full Width?	N/A
N/A	Landing Curb? (Y/N)	N/A	N/A	DWS Offset LT (in)	N/A
N/A	Shared Landing?	N/A	N/A	DWS Offset RT (in)	N/A
N/A	Gutter Ponding?	0.0	N/A	Gutter Slope (%)	N/A
N/A	Gutter Lip Ht (in)	0.0	N/A	Gutter X Slope (%)	N/A
N/A	Painted X Walk1?	No		Road Slope (%)	1.8
	X Walk 1 Direction	To NE		Road X Slope (%)	0.2
	X Walk 1 Width (in)	N/A		Clear Space?	N/A

X Walk 1 Slope (%)	1.8	N/A	Clear Space to XWalk (in)	N/A
	X Walk 1 X Slope (%)	0.2	N/A	Storm Grate/Utility Hazard?	N/A
N/A	Ramp inside XWalk1?	N/A		Storm Grate/Utility Type	
N/A	Any Obstructions?	N/A			N/A
	Obstruction Type		Yes	Surface Condition? (G/P)	Good
			N/A	Curb Slope (%)	1.0

Possible Solutions:

**Remove & Replace Entire Ramp.**
