Access Compliance Report Public Rights-of-Way (Curb Ramps)

Intersection ID: 10662	Main Street: E_36TH_ST	Cross Street: HOLT_ST	Location: S
ADA ID: DA47B9D5989B	Ramp Type: ParaDiag	Initial Pass/Fail: Pass	Overall Compliance: No Severity Score: 12.75

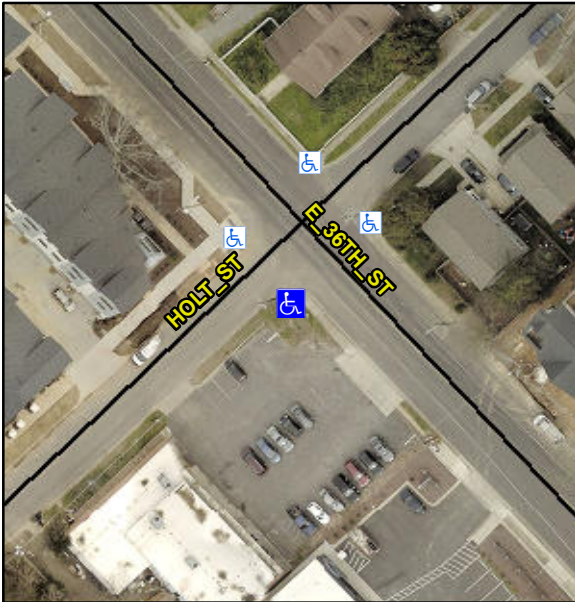
RT RP < 5%

Compliance	Description	Data	Compliance	Description	Data
N/A	Ramp Length LT (in)	40.0	N/A	Ramp Length RT (in)	25.5
Yes	Ramp Width LT (in)	59.0	Yes	Ramp Width RT (in)	59.0
Yes	Ramp Slope LT (%)	6.3	Yes	Ramp Slope RT (%)	2.0
No	Ramp XSlope LT (%)	2.1	Yes	Ramp XSlope RT (%)	1.8
Yes	Landing Length (in)	59.5	Yes	DWS Provided?	Yes
Yes	Landing Width (in)	48.0	Yes	DWS Contrast?	Yes
No	Landing Slope (%)	4.1	Yes	DWS Length (in)	24.5
No	Landing X Slope (%)	3.7	Yes	DWS Full Width?	Yes
N/A	Landing Curb? (Y/N)	No	No	DWS Offset (in)	4.0
N/A	Shared Landing?	No			
Yes	Gutter Ponding?	No	No	Gutter Slope (%)	9.4
No	Gutter Lip Ht (in)	0.5	No	Gutter X Slope (%)	4.4
N/A	Painted X Walk1?	No	N/A	Painted X Walk2?	No
	X Walk 1 Direction	To NE		X Walk 2 Direction	To NW
N/A	X Walk 1 Width (in)	N/A	N/A	X Walk 2 Width (in)	N/A
	X Walk 1 Slope (%)	2.2		X Walk 2 Slope (%)	1.1
	X Walk 1 X Slope (%)	1.3		X Walk 2 X Slope (%)	1.2
N/A	Ramp inside XWalk1?	N/A	N/A	Ramp inside XWalk2?	N/A

Road Slope (%)	2.4	N/A	Clear Space?	Yes
	Road X Slope (%)	2.0	N/A	Clear Space to XWalk (in)	N/A
Yes	Any Obstructions?	No	Yes	Storm Grate/Utility Hazard?	No
	Obstruction Type			Storm Grate/Utility Type	
		N/A			N/A
			Yes	Surface Condition? (G/P)	Good
			N/A	Curb Slope (%)	20.9

Remove & Replace Curb Ramp With Two New Directional Ramps or Equivalent. Remove & Replace Gutter.
