# Access Compliance Report

## Public Rights-of-Way

### (Curb Ramps)

| Intersection ID: 46317 | Main Street: MAGNASCO_LN | Cross Street: BREWER_DR | Location: | N |

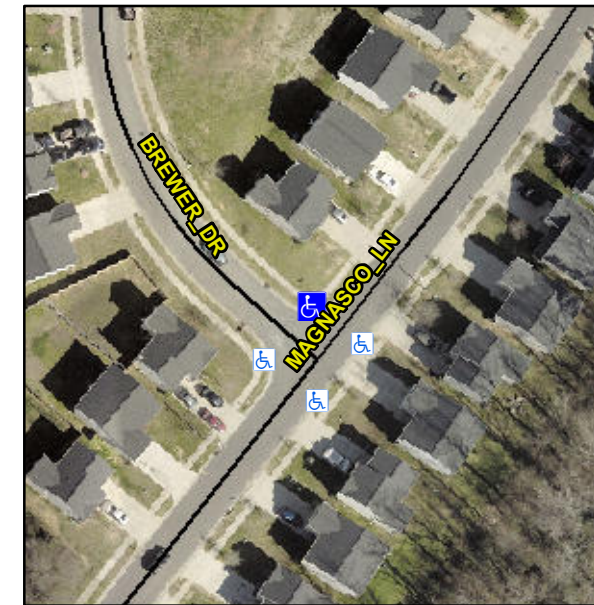
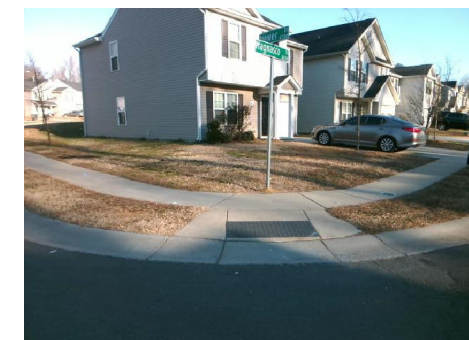
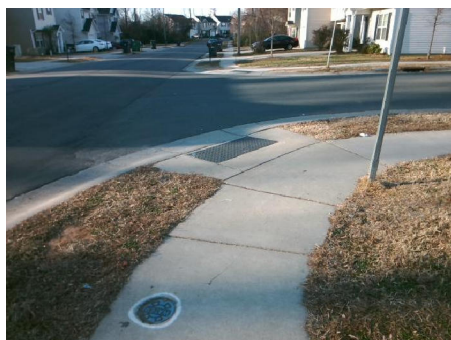
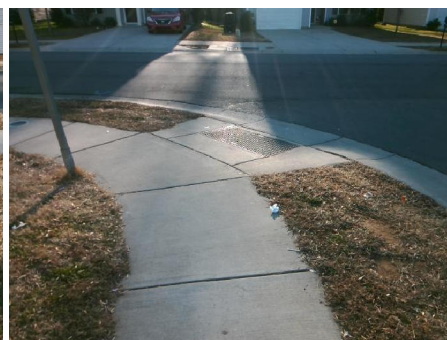
| ADA ID: DA4AD5165C8A | Ramp Type: PerpDiag | Initial Pass/Fail: Fail | Overall Compliance: No | Severity Score: 22.5 |

**Not Found, R304.5.1, R304.2.2, R304.5.3**

| Compliance | Description | Data | Compliance | Description | Data |
|---|---|---|---|---|---|
| N/A | Ramp Length (in) | 48.0 | No | Ramp Slope (%) | 9.3 |
| No | Ramp Width (in) | 47.0 | No | Ramp XSlope (%) | 2.2 |

**Remove & Replace Curb Ramp With Two New Directional Ramps or Equivalent.**
