# Access Compliance Report

## Public Rights-of-Way

### (Curb Ramps)

| Intersection ID: 6063 | Main Street: ALPINE_LN | Cross Street: HOOVER_DR | Location: NW |

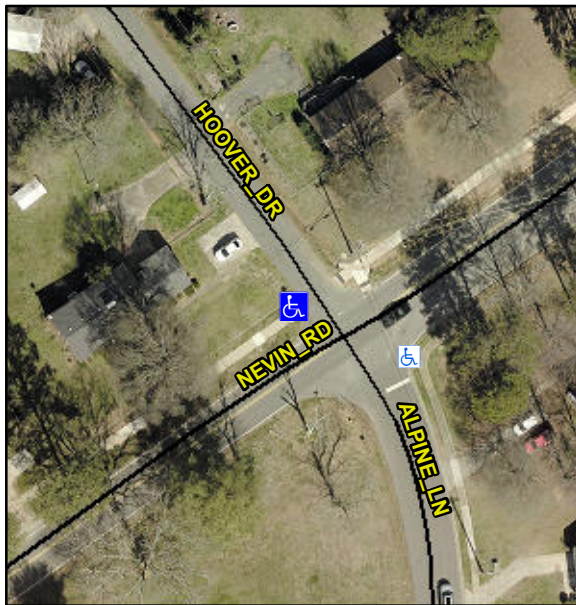
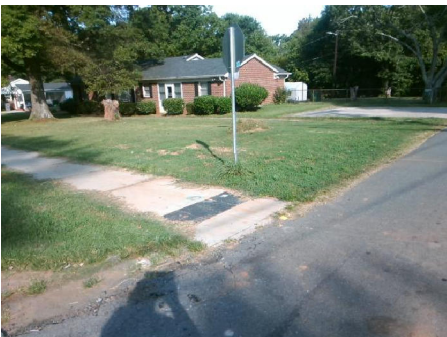
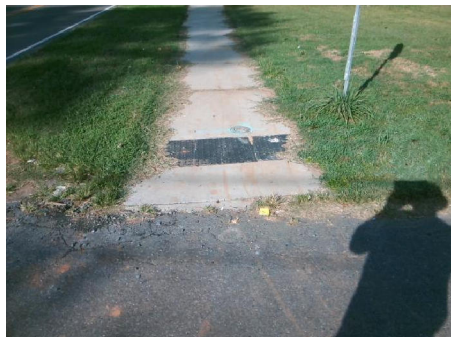
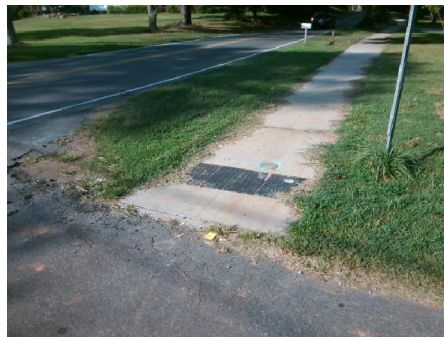
**NO CURB**

| Compliance | Description | Data | Compliance | Description | Data |
|---|---|---|---|---|---|
| No | Landing Slope (%) | 3.0 | Yes | DWS Length (in) | 24.0 |
| N/A | Landing Curb? (Y/N) | No | No | DWS Offset (in) | 25.0 |

**Remove & Replace Curb Ramp With Two New Directional Ramps or Equivalent.**

**R304.2.2-Perp, R304.3.2-Para, R305.2**
