Access Compliance Report

Public Rights-of-Way

(Curb Ramps)

Intersection ID: 32079	Main Street: ASHGROVE_LN	Cross Street: KEEGAN_WY	Location: S
ADA ID: DA5F0F84BC0D	Ramp Type: PerpDiag	Initial Pass/Fail: Fail	Overall Compliance: No
Severity Score: 60			
Codes/Mitigation Info/Possible Solution		Field Measurements/Component Compliance

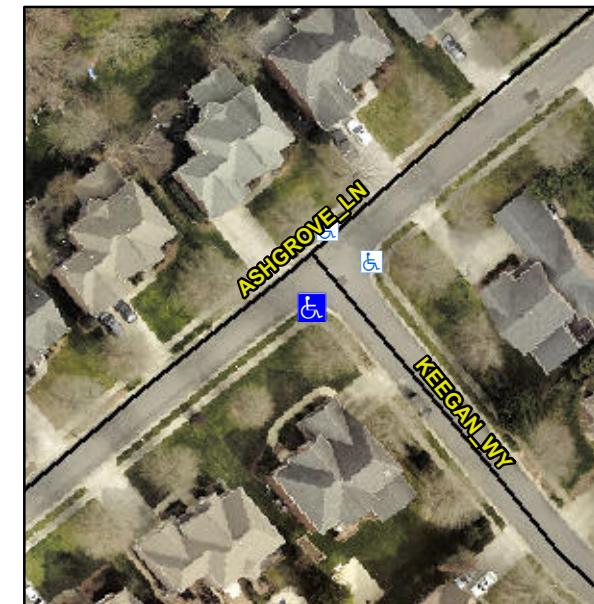
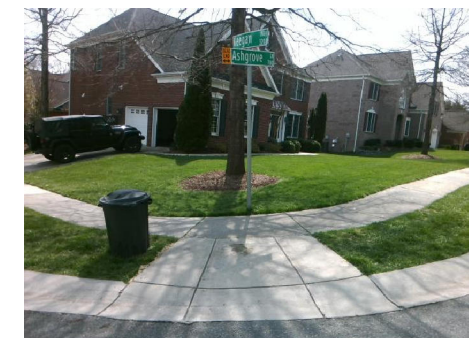
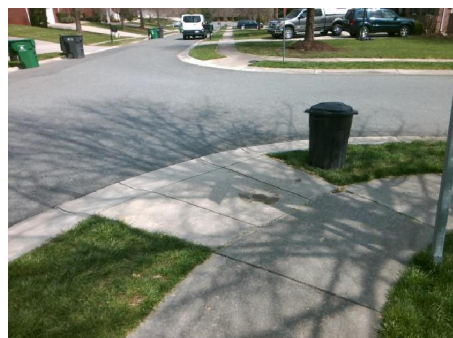
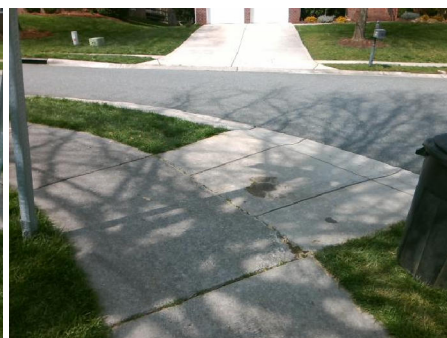
Not Found, R304.5.1, R304.5.3

Compliance	Description	Data	Compliance	Description	Data
N/A	Ramp Length (in)	55.5	Yes	Ramp Slope (%)	6.2
No	Ramp Width (in)	31.5	No	Ramp XSlope (%)	11.3
N/A	Flare Type LT	N/A	N/A	Flare Type RT	N/A
N/A	Flare Slope LT (%)	N/A	N/A	Flare Slope RT (%)	N/A
N/A	Flare Traversable LT?	N/A	N/A	Flare Traversable RT?	N/A
N/A	Landing Length (in)	N/A	N/A	DWS Provided?	N/A
N/A	Landing Width (in)	N/A	N/A	DWS Contrast?	N/A
N/A	Landing Slope (%)	N/A	N/A	DWS Length (in)	N/A
N/A	Landing X Slope (%)	N/A	N/A	DWS Full Width?	N/A
N/A	Landing Curb? (Y/N)	N/A	N/A	DWS Offset (in)	N/A
N/A	Shared Landing?	N/A			
N/A	Gutter Ponding?	N/A	N/A	Gutter Slope (%)	N/A
N/A	Gutter Lip Ht (in)	N/A	N/A	Gutter X Slope (%)	N/A
N/A	Painted X Walk1?	No	N/A	Painted X Walk2?	No
	X Walk 1 Direction	To NE		X Walk 2 Direction	To NW
N/A	X Walk 1 Width (in)	N/A	N/A	X Walk 2 Width (in)	N/A
	X Walk 1 Slope (%)	1.8		X Walk 2 Slope (%)	5.7
	X Walk 1 X Slope (%)	7.6		X Walk 2 X Slope (%)	2.6

N/A	Ramp inside XWalk1?	N/A	N/A	Ramp inside XWalk2?	N/A
	Road Slope (%)	9.1	N/A	Clear Space?	N/A
	Road X Slope (%)	5.1	N/A	Clear Space to XWalk (in)	N/A
N/A	Any Obstructions?	N/A	N/A	Storm Grate/Utility Hazard?	N/A
	Obstruction Type			Storm Grate/Utility Type	
		N/A			N/A
			Yes	Surface Condition? (G/P)	Good

Possible Solutions:

Remove & Replace Curb Ramp With Two New Directional Ramps or Equivalent.
