Intersection ID: 8266	Main Street: CATHERINE_SIMMONS_AV	Cross Street: MADRID_ST	Location:	SW
ADA ID: DA649129675B	Ramp Type: ParaDiag	Initial Pass/Fail: Fail	Overall Compliance: No	Severity Score: 13.75

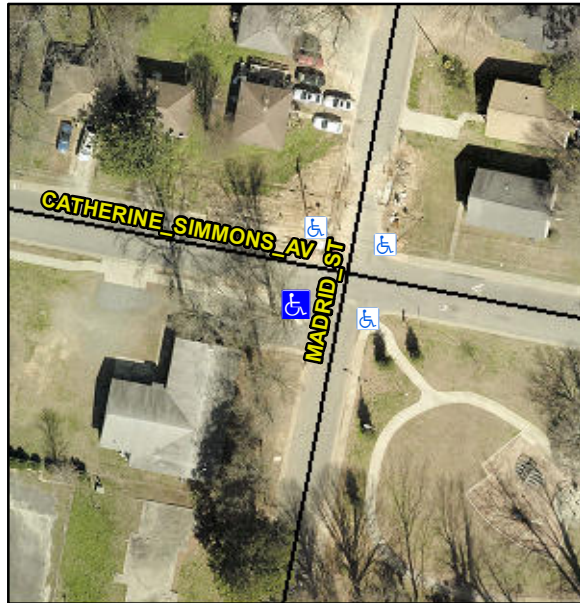
LT RP < 5%

R304.5.3, R304.3.2

Compliance	Description	Data	Compliance	Description	Data
N/A	Ramp Length LT (in)	49.5	N/A	Ramp Length RT (in)	137.5
Yes	Ramp Width LT (in)	72.0	Yes	Ramp Width RT (in)	80.0
Yes	Ramp Slope LT (%)	1.6	No	Ramp Slope RT (%)	9.4
No	Ramp XSlope LT (%)	2.2	Yes	Ramp XSlope RT (%)	1.6
N/A	Landing Length (in)	N/A	N/A	DWS Provided?	N/A
N/A	Landing Width (in)	N/A	N/A	DWS Contrast?	N/A
N/A	Landing Slope (%)	N/A	N/A	DWS Length (in)	N/A
N/A	Landing X Slope (%)	N/A	N/A	DWS Full Width?	N/A
N/A	Landing Curb? (Y/N)	N/A	N/A	DWS Offset (in)	N/A
N/A	Shared Landing?	N/A			
N/A	Gutter Ponding?	N/A	N/A	Gutter Slope (%)	N/A
N/A	Gutter Lip Ht (in)	N/A	N/A	Gutter X Slope (%)	N/A
N/A	Painted X Walk1?	No	N/A	Painted X Walk2?	No
	X Walk 1 Direction	To E		X Walk 2 Direction	To N
N/A	X Walk 1 Width (in)	N/A	N/A	X Walk 2 Width (in)	N/A
	X Walk 1 Slope (%)	6.1		X Walk 2 Slope (%)	4.5
	X Walk 1 X Slope (%)	4.9		X Walk 2 X Slope (%)	3.8
N/A	Ramp inside XWalk1?	N/A	N/A	Ramp inside XWalk2?	N/A

Road Slope (%)	5.5	N/A	Clear Space?	N/A
	Road X Slope (%)	1.1	N/A	Clear Space to XWalk (in)	N/A
N/A	Any Obstructions?	N/A	N/A	Storm Grate/Utility Hazard?	N/A
	Obstruction Type			Storm Grate/Utility Type	
		N/A			N/A
			Yes	Surface Condition? (G/P)	Good
			N/A	Curb Slope (%)	12.4

Remove & Replace Curb Ramp With Two New Directional Ramps or Equivalent.
