# Access Compliance Report

## Public Rights-of-Way

### (Curb Ramps)

| Intersection ID: 49140 | Main Street: POPE_FARM_RD | Cross Street: CEMKEY_WAY_CT | Location: SE |

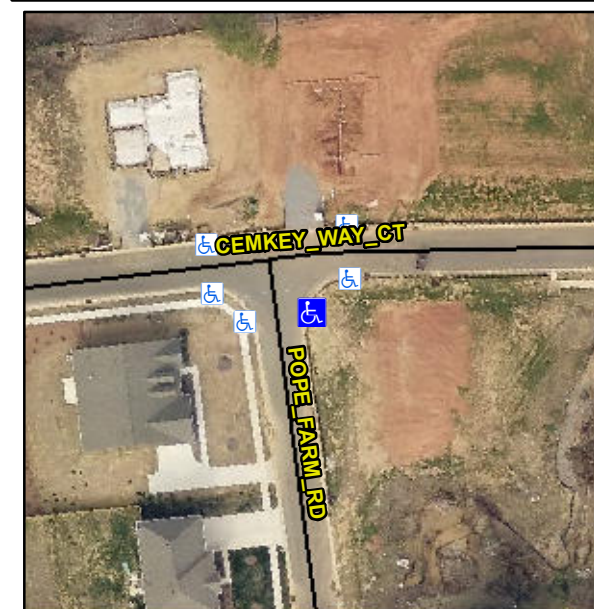
| ADA ID: DA64F65221A7 | Ramp Type: Perp | Initial Pass/Fail: Fail | Overall Compliance: No |
| Severity Score: 8.75 | | | |

**Not Found, R304.5.1**

| Compliance | Description | Data | Compliance | Description | Data |
|---|---|---|---|---|---|
| No | Ramp Width (in) | 46.0 | Yes | Ramp XSlope (%) | 0.9 |

**Remove & Replace Entire Ramp.**

Total Cost: \$ 1850.00
