# Access Compliance Report

## Public Rights-of-Way

### (Curb Ramps)

| Intersection ID: 10028610 | Main Street: HONOR_GUARD_AV | Cross Street: N/A | Location: SE |

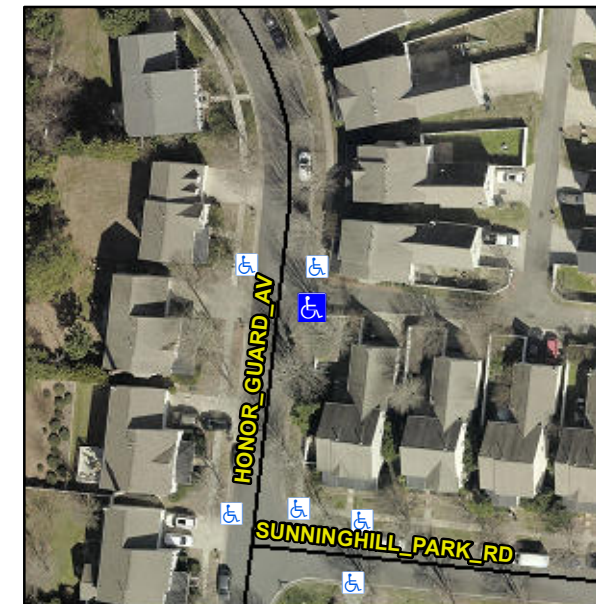
| ADA ID: DA68E3941E21 | Ramp Type: BlendTrans1 | Initial Pass/Fail: Fail | Overall Compliance: No |
| Severity Score: 30 | | | |

**R304.5.1, R304.5.3**

| Compliance | Description | Data | Compliance | Description | Data |
|---|---|---|---|---|---|
| No | Ramp Width (in) | 32.0 | No | BlendTrans XSlope (%) | 5.9 |

**Remove & Replace Curb Ramp With Two New Directional Ramps or Equivalent.**

Total Cost: \$ 3200.00
