## Access Compliance Report Public Rights-of-Way (Curb Ramps)

Intersection ID: 15011Main Street: ALBEMARLE\_RDCross Street: COPPER\_CREEK\_CTLocation:SWADA ID: DA6CD065EEF0Ramp Type: PerpDiagInitial Pass/Fail: FailOverall Compliance: NoSeverity Score:10

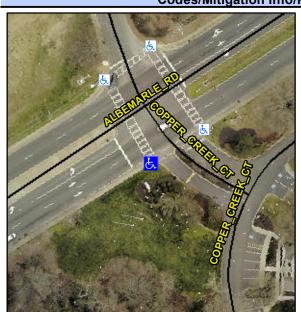
Not Found, R304.5.1, R304.5.3

Compliance Description Data Compliance Description Data					
N/A Ramp Length (in)		60.0	Yes	Ramp Slope (%)	8.0
No	Ramp Width (in)	47.0	No	Ramp XSlope (%)	2.4
N/A	Flare Type LT	N/A	N/A	Flare Type RT	N/A
N/A	Flare Slope LT (%)	N/A	N/A	Flare Slope RT (%)	N/A
N/A	Flare Traversable LT?	N/A	N/A	Flare Traversable RT?	N/A
N/A	Landing Length (in)	N/A	N/A	DWS Provided?	N/A
N/A	Landing Width (in)	N/A	N/A	DWS Contrast?	N/A
N/A	Landing Slope (%)	N/A	N/A	DWS Length (in)	N/A
N/A	• ,		N/A	DWS Full Width?	
	Landing X Slope (%)	N/A			N/A
N/A	Landing Curb? (Y/N)	N/A	N/A	DWS Offset (in)	N/A
N/A	Shared Landing?	N/A		0 " 0 (0/)	
N/A	Gutter Ponding?	N/A	N/A	Gutter Slope (%)	N/A
N/A	Gutter Lip Ht (in)	N/A	N/A	Gutter X Slope (%)	N/A
N/A	Painted X Walk1?	Yes	N/A	Painted X Walk2?	Yes
	X Walk 1 Direction	То Е		X Walk 2 Direction	To N
N/A	X Walk 1 Width (in)	72.5	N/A	X Walk 2 Width (in)	102.5
	X Walk 1 Slope (%)	3.1		X Walk 2 Slope (%)	3.2

X Walk 1 X Slope (%)	1.9		X Walk 2 X Slope (%)	1.6
N/A	Ramp inside XWalk1?	Yes	N/A	Ramp inside XWalk2?	Yes
	Road Slope (%)	0.6	N/A	Clear Space?	N/A
	Road X Slope (%)	2.7	N/A	Clear Space to XWalk (in)	N/A
N/A	Any Obstructions?	N/A	N/A	Storm Grate/Utility Hazard?	N/A
	Obstruction Type			Storm Grate/Utility Type	
		N/A			N/A
			Yes	Surface Condition? (G/P)	Good
		'	-	` '

Remove & Replace Curb Ramp With Two New Directional Ramps or Equivalent.
