# Access Compliance Report

## Public Rights-of-Way

Intersection ID: 42696	Main Street: SHARON_VIEW_RD	Cross Street: WINDING_CREEK_LN	Location: NE
ADA ID: DA728C16B154	Ramp Type: PerpDiag	Initial Pass/Fail: Fail	Overall Compliance: No
Severity Score: 46.25			
Codes/Mitigation Info/Possible Solution		Field Measurements/Component Compliance

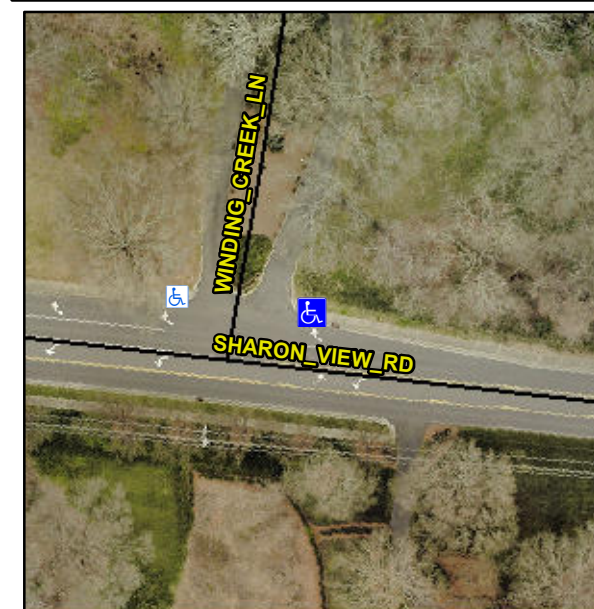
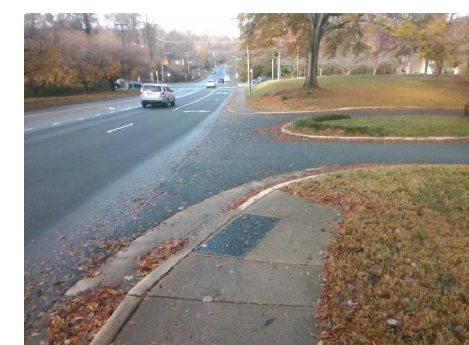
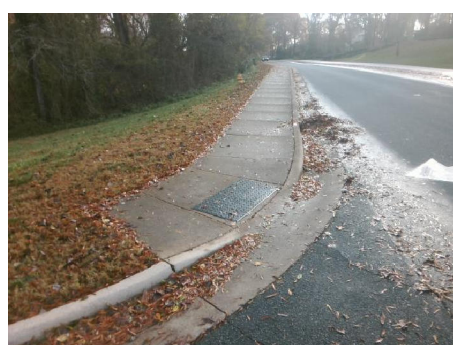
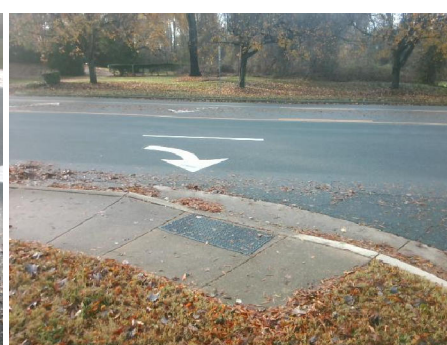
**Not Found, R304.5.1, R304.2.2, R304.5.3**

Compliance	Description	Data	Compliance	Description	Data
N/A	Ramp Length (in)	60.0	No	Ramp Slope (%)	13.5
No	Ramp Width (in)	43.0	No	Ramp XSlope (%)	5.8
N/A	Flare Type LT	N/A	N/A	Flare Type RT	N/A
N/A	Flare Slope LT (%)	N/A	N/A	Flare Slope RT (%)	N/A
N/A	Flare Traversable LT?	N/A	N/A	Flare Traversable RT?	N/A
N/A	Landing Length (in)	N/A	N/A	DWS Provided?	N/A
N/A	Landing Width (in)	N/A	N/A	DWS Contrast?	N/A
N/A	Landing Slope (%)	N/A	N/A	DWS Length (in)	N/A
N/A	Landing X Slope (%)	N/A	N/A	DWS Full Width?	N/A
N/A	Landing Curb? (Y/N)	N/A	N/A	DWS Offset (in)	N/A
N/A	Shared Landing?	N/A			
N/A	Gutter Ponding?	N/A	N/A	Gutter Slope (%)	N/A
N/A	Gutter Lip Ht (in)	N/A	N/A	Gutter X Slope (%)	N/A
N/A	Painted X Walk1?	No	N/A	Painted X Walk2?	No
	X Walk 1 Direction	To NW		X Walk 2 Direction	To SW
N/A	X Walk 1 Width (in)	N/A	N/A	X Walk 2 Width (in)	N/A
	X Walk 1 Slope (%)	9.4		X Walk 2 Slope (%)	0.9
	X Walk 1 X Slope (%)	3.4		X Walk 2 X Slope (%)	6.3

N/A	Ramp inside XWalk1?	N/A	N/A	Ramp inside XWalk2?	N/A
	Road Slope (%)	4.6	N/A	Clear Space?	N/A
	Road X Slope (%)	4.2	N/A	Clear Space to XWalk (in)	N/A
N/A	Any Obstructions?	N/A	N/A	Storm Grate/Utility Hazard?	N/A
	Obstruction Type			Storm Grate/Utility Type	
		N/A			N/A
		Yes		Surface Condition? (G/P)	Good

**Remove & Replace Curb Ramp With Two New Directional Ramps or Equivalent.**
