Access Compliance Report

Public Rights-of-Way

(Curb Ramps)

| Intersection ID: N/A | Main Street: PINEVILLE-MATTHEWS_RD | Cross Street: N/A | Location: SW |

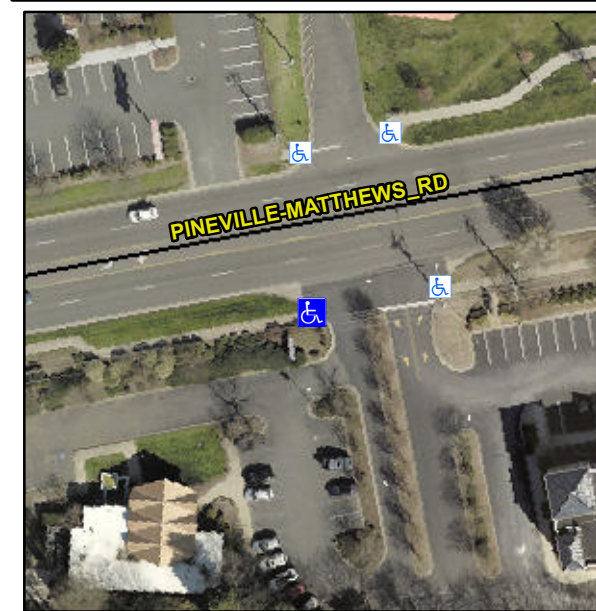
| ADA ID: DA7BFDE8B519 | Ramp Type: PerpDiag | Initial Pass/Fail: Fail | Overall Compliance: No |
| Severity Score: 22.5 | | | |

Not Found, R304.5.1, R304.2.2, R304.5.3

| Compliance | Description | Data | Compliance | Description | Data |
|---|---|---|---|---|---|
| N/A | Ramp Length (in) | 45.0 | No | Ramp Slope (%) | 10.0 |
| No | Ramp Width (in) | 41.0 | No | Ramp XSlope (%) | 3.0 |

Possible Solutions:

Remove & Replace Curb Ramp With Two New Directional Ramps or Equivalent.

Total Cost: \$ 3200.00
