Access Compliance Report

Public Rights-of-Way

(Curb Ramps)

Intersection ID: 44275	Main Street: JOSEPH_HOWARD_CT	Cross Street: BRITNI_DAYLE_DR	Location: S
ADA ID: DA7DF2C03BE0	Ramp Type: PerpDiag	Initial Pass/Fail: Fail	Overall Compliance: No
		Severity Score: 22.5

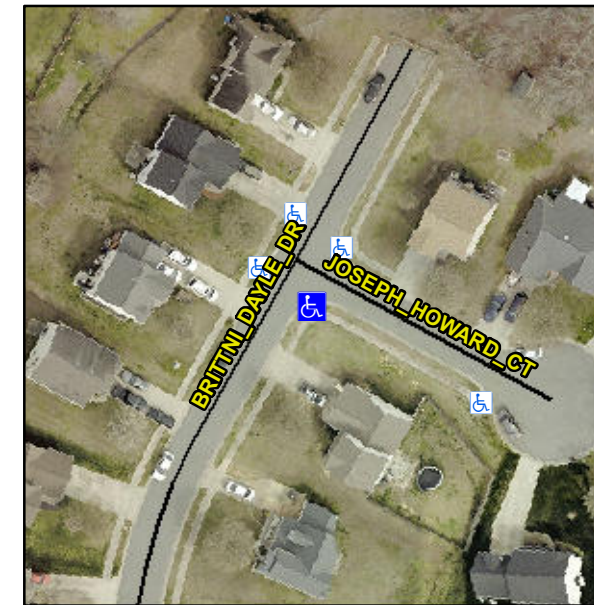
Compliance	Description	Data	Compliance	Description	Data
N/A	Ramp Length (in)	47.0	No	Ramp Slope (%)	8.4
No	Ramp Width (in)	46.5	No	Ramp XSlope (%)	3.2
N/A	Flare Type LT	N/A	N/A	Flare Type RT	N/A
N/A	Flare Slope LT (%)	N/A	N/A	Flare Slope RT (%)	N/A
N/A	Flare Traversable LT?	N/A	N/A	Flare Traversable RT?	N/A
N/A	Landing Length (in)	N/A	N/A	DWS Provided?	N/A
N/A	Landing Width (in)	N/A	N/A	DWS Contrast?	N/A
N/A	Landing Slope (%)	N/A	N/A	DWS Length (in)	N/A
N/A	Landing X Slope (%)	N/A	N/A	DWS Full Width?	N/A
N/A	Landing Curb? (Y/N)	N/A	N/A	DWS Offset (in)	N/A
N/A	Shared Landing?	N/A			
N/A	Gutter Ponding?	N/A	N/A	Gutter Slope (%)	N/A
N/A	Gutter Lip Ht (in)	N/A	N/A	Gutter X Slope (%)	N/A
N/A	Painted X Walk1?	No	N/A	Painted X Walk2?	No
	X Walk 1 Direction	To NE		X Walk 2 Direction	To NW
N/A	X Walk 1 Width (in)	N/A	N/A	X Walk 2 Width (in)	N/A
	X Walk 1 Slope (%)	4.5		X Walk 2 Slope (%)	2.8
	X Walk 1 X Slope (%)	0.4		X Walk 2 X Slope (%)	3.5

N/A	Ramp inside XWalk1?	N/A	N/A	Ramp inside XWalk2?	N/A
	Road Slope (%)	0.3	N/A	Clear Space?	N/A
	Road X Slope (%)	5.9	N/A	Clear Space to XWalk (in)	N/A
N/A	Any Obstructions?	N/A	N/A	Storm Grate/Utility Hazard?	N/A
	Obstruction Type			Storm Grate/Utility Type	
		N/A			N/A
			Yes	Surface Condition? (G/P)	Good

Possible Solutions:

Remove & Replace Curb Ramp With Two New Directional Ramps or Equivalent.

Not Found, R304.5.1, R304.2.2, R304.5.3
