## Access Compliance Report Public Rights-of-Way (Curb Ramps)

Intersection ID: 15805Main Street:LAWYERS\_RDCross Street:WALNUT\_GROVE\_LNLocation:SWADA ID: DA7FC2BDEAB3Ramp Type:PerpDiagInitial Pass/Fail:FailOverall Compliance:NoSeverity Score:37.5

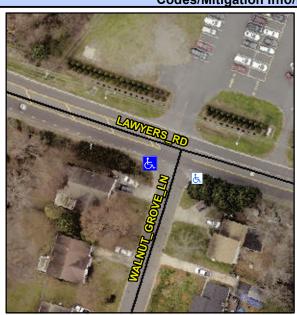
Field Measurements/Component Compliance					
Compliance Description		Data	Compliance Description		Data
N/A	Ramp Length (in)	55.0	No	Ramp Slope (%)	12.7
Yes	Ramp Width (in)	56.0	No	Ramp XSlope (%)	6.1
N/A	Flare Type LT	N/A	N/A	Flare Type RT	N/A
N/A	Flare Slope LT (%)	N/A	N/A	Flare Slope RT (%)	N/A
N/A	Flare Traversable LT?	N/A	N/A	Flare Traversable RT?	N/A
N/A	Landing Length (in)	N/A	N/A	DWS Provided?	N/A
N/A	Landing Width (in)	N/A	N/A	DWS Contrast?	N/A
N/A	Landing Slope (%)	N/A	N/A	DWS Length (in)	N/A
N/A	Landing X Slope (%)	N/A	N/A	DWS Full Width?	N/A
N/A	Landing Curb? (Y/N)	N/A	N/A	DWS Offset (in)	N/A
N/A	Shared Landing?	N/A			
N/A	Gutter Ponding?	N/A	N/A	Gutter Slope (%)	N/A
N/A	Gutter Lip Ht (in)	1.0	N/A	Gutter X Slope (%)	N/A
N/A	Painted X Walk1?	No	N/A	Painted X Walk2?	No
	X Walk 1 Direction	To SE		X Walk 2 Direction	To NE
N/A	X Walk 1 Width (in)	N/A	N/A	X Walk 2 Width (in)	N/A
	X Walk 1 Slope (%)	0.2		X Walk 2 Slope (%)	6.9

X Walk 1 X Slope (%)	6.4		X Walk 2 X Slope (%)	0.5
N/A	Ramp inside XWalk1?	N/A	N/A	Ramp inside XWalk2?	N/A
	Road Slope (%)	3.1	N/A	Clear Space?	N/A
	Road X Slope (%)	4.2	N/A	Clear Space to XWalk (in)	N/A
N/A	Any Obstructions?	N/A	N/A	Storm Grate/Utility Hazard?	N/A
	Obstruction Type			Storm Grate/Utility Type	
		N/A			N/A
			Yes	Surface Condition? (G/P)	Good
Mile S	Maria de Carlo Maria da

Remove & Replace Curb Ramp With
Two New Directional Ramps or
Equivalent.

R304.2.2, R304.5.3
