Access Compliance Report

Public Rights-of-Way

(Curb Ramps)

Intersection ID: N/A	Main Street: E_3RD_ST	Cross Street: S_CALDWELL_ST	Location: W
ADA ID: DA80264837A7	Ramp Type: Perp	Initial Pass/Fail: Fail	Overall Compliance: No
		Severity Score: 8.75	
Codes/Mitigation Info/Possible Solution		Field Measurements/Component Compliance

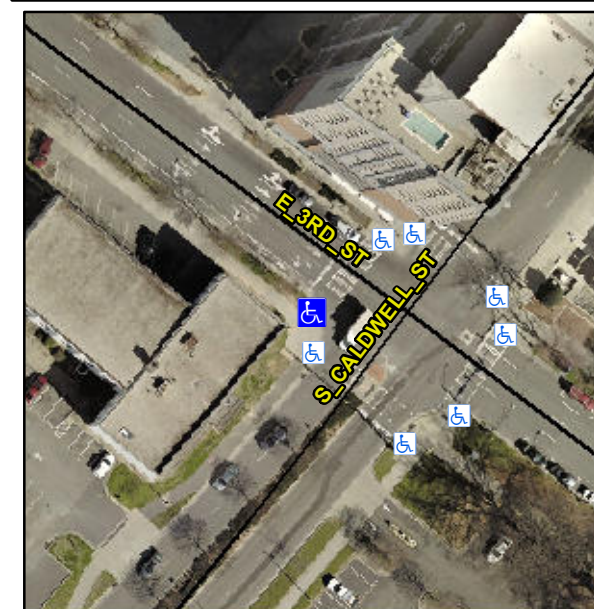
Not Found, R304.5.1

Compliance	Description	Data	Compliance	Description	Data
N/A	Ramp Length (in)	95.0	Yes	Ramp Slope (%)	7.4
No	Ramp Width (in)	47.0	Yes	Ramp XSlope (%)	0.7
N/A	Flare Type LT	N/A	N/A	Flare Type RT	N/A
N/A	Flare Slope LT (%)	N/A	N/A	Flare Slope RT (%)	N/A
N/A	Flare Traversable LT?	No	N/A	Flare Traversable RT?	No
N/A	Landing Length (in)	N/A	N/A	DWS Provided?	N/A
N/A	Landing Width (in)	N/A	N/A	DWS Contrast?	N/A
N/A	Landing Slope (%)	N/A	N/A	DWS Length (in)	N/A
N/A	Landing X Slope (%)	N/A	N/A	DWS Full Width?	N/A
N/A	Landing Curb? (Y/N)	N/A	N/A	DWS Offset (in)	N/A
N/A	Shared Landing?	N/A			
N/A	Gutter Ponding?	N/A	N/A	Gutter Slope (%)	N/A
N/A	Gutter Lip Ht (in)	N/A	N/A	Gutter X Slope (%)	N/A
N/A	Painted X Walk1?	Yes	N/A	Painted X Walk2?	N/A
	X Walk 1 Direction	To NE		X Walk 2 Direction	N/A
N/A	X Walk 1 Width (in)	121.0	N/A	X Walk 2 Width (in)	N/A
	X Walk 1 Slope (%)	4.7		X Walk 2 Slope (%)	N/A
	X Walk 1 X Slope (%)	0.6		X Walk 2 X Slope (%)	N/A

N/A	Ramp inside XWalk1?	Yes	N/A	Ramp inside XWalk2?	N/A
	Road Slope (%)	N/A	N/A	Clear Space?	N/A
	Road X Slope (%)	N/A	N/A	Clear Space to XWalk (in)	N/A
N/A	Any Obstructions?	N/A	N/A	Storm Grate/Utility Hazard?	N/A
	Obstruction Type			Storm Grate/Utility Type	
		N/A			N/A
			Yes	Surface Condition? (G/P)	Good

Remove & Replace Entire Ramp.

Total Cost: \$ 1850.00
