# Access Compliance Report

## Public Rights-of-Way

### (Curb Ramps)

Intersection ID: 3215	Main Street: BELLMORE_CT	Cross Street: OLD_BRIDGE_LN	Location: S
ADA ID: DA858639FDBB	Ramp Type: Perp	Initial Pass/Fail: Pass	Overall Compliance: No
		Severity Score: 0

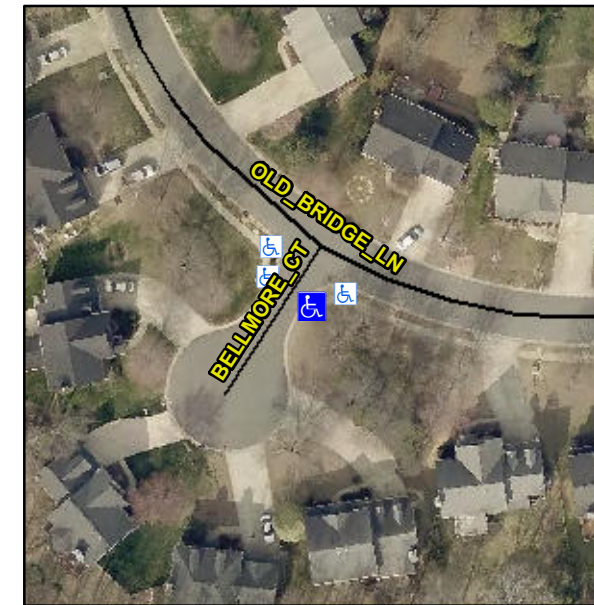
**Not Found, R304.2.1**

Compliance	Description	Data	Compliance	Description	Data
N/A	Ramp Length (in)	47.0	Yes	Ramp Slope (%)	6.2
Yes	Ramp Width (in)	48.0	Yes	Ramp XSlope (%)	0.3
N/A	Flare Type LT	Sloped	N/A	Flare Type RT	N/A
N/A	Flare Slope LT (%)	3.7	N/A	Flare Slope RT (%)	0.9
N/A	Flare Traversable LT?	No	N/A	Flare Traversable RT?	No
No	Landing Length (in)	46.0	Yes	DWS Provided?	Yes
Yes	Landing Width (in)	48.0	Yes	DWS Contrast?	Yes
Yes	Landing Slope (%)	1.4	Yes	DWS Length (in)	25.5
Yes	Landing X Slope (%)	1.4	Yes	DWS Full Width?	Yes
N/A	Landing Curb? (Y/N)	No	Yes	DWS Offset (in)	2.0
N/A	Shared Landing?	No			
Yes	Gutter Ponding?	No	Yes	Gutter Slope (%)	2.1
Yes	Gutter Lip Ht (in)	0.0	Yes	Gutter X Slope (%)	0.0
N/A	Painted X Walk1?	No	N/A	Painted X Walk2?	N/A
	X Walk 1 Direction	To NW		X Walk 2 Direction	N/A
N/A	X Walk 1 Width (in)	N/A	N/A	X Walk 2 Width (in)	N/A
	X Walk 1 Slope (%)	3.4		X Walk 2 Slope (%)	N/A
	X Walk 1 X Slope (%)	3.4		X Walk 2 X Slope (%)	N/A

N/A	Ramp inside XWalk1?	N/A	N/A	Ramp inside XWalk2?	N/A
	Road Slope (%)	N/A	N/A	Clear Space?	Yes
	Road X Slope (%)	N/A	N/A	Clear Space to XWalk (in)	N/A
Yes	Any Obstructions?	No	Yes	Storm Grate/Utility Hazard?	No
	Obstruction Type			Storm Grate/Utility Type	
			N/A		N/A
			Yes	Surface Condition? (G/P)	Good

Possible Solutions:

**Remove & Replace Entire Ramp.**
