## **Access Compliance Report Public Rights-of-Way** (Curb Ramps)

Intersection ID: N/A Main Street: REMOUNT\_RD Cross Street: PARKER\_DR Location: SW **Overall Compliance: No** ADA ID: DA86745BC0E6 Ramp Type: Directional1 Initial Pass/Fail: Fail **Severity Score:** 1.25

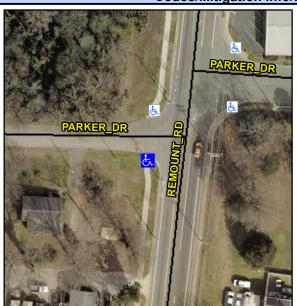
Compl	iance Description	Data	Comp	liance	Description	Data
N/A	Ramp Length (in)	88.0	N/A	Grad	e Break?	N/A
Yes	Ramp Width (in)	72.0	N/A	Grade Break Slope (%)		0.0
Yes	Ramp Slope (%)	3.3	N/A	Grade Break XSlope (%)		0.0
No	Ramp XSlope (%)	2.5				
N/A	Flare Type LT	N/A	N/A	Flare Type RT		N/A
N/A	Flare Slope LT (%)	N/A	N/A	Flare Slope RT (%)		0.0
N/A	Flare Traversable LT?	N/A	N/A	Flare Traversable RT?		N/A
N/A	Landing Length (in)	0.0	N/A	DWS	Provided?	N/A
N/A	Landing Width (in)	0.0	N/A	DWS	Contrast?	N/A
N/A	Landing Slope (%)	0.0	N/A	DWS	Length (in)	N/A
N/A	Landing X Slope (%)	0.0	N/A	DWS	Full Width?	N/A
N/A	Landing Curb? (Y/N)	N/A	N/A	DWS	Offset LT (in)	N/A
N/A	Shared Landing?	N/A	N/A	DWS	Offset RT (in)	N/A
N/A	Gutter Ponding?	0.0	N/A	Gutte	r Slope (%)	N/A
N/A	Gutter Lip Ht (in)	0.0	N/A	Gutter X Slope (%)		N/A
N/A	Painted X Walk1?	No		Road	Slope (%)	0.6
	X Walk 1 Direction	To NW		Road	X Slope (%)	2.0
	X Walk 1 Width (in)	N/A		Clear	Space?	N/A

X Walk 1 Slope (%)	0.6	N/A	Clear	Space to XWalk (in)	N/A
	X Walk 1 X Slope (%)	2.0	N/A	Storn	n Grate/Utility Hazard?	N/A
N/A	Ramp inside XWalk1?	N/A		Storn	n Grate/Utility Type	
N/A	Any Obstructions?	N/A				N/A
	Obstruction Type		Yes	Surfa	ce Condition? (G/P)	Good
		N/A	N/A	Curb	Slope (%)	5.8

Possible Solutions:	Con
Remove & Replace Entire Ramp.	N/A
•	Yes
	Yes
	No
	N/A
	N/A
Surveyor Notes:	N/A
N/A	N/A
	N/A
	N/A
	N/A
PROW/ADA:	N/A
R304.5.3	N/A
	N/A
	N/A
	N/A
