Access Compliance Report

Public Rights-of-Way

(Curb Ramps)

Intersection ID: 12704	Main Street: E_5TH_ST	Cross Street: N_DAVIDSON_ST	Location: N
ADA ID: DA886ECE1D6B	Ramp Type: PerpDiag	Initial Pass/Fail: Fail	Overall Compliance: No
		Severity Score: 25

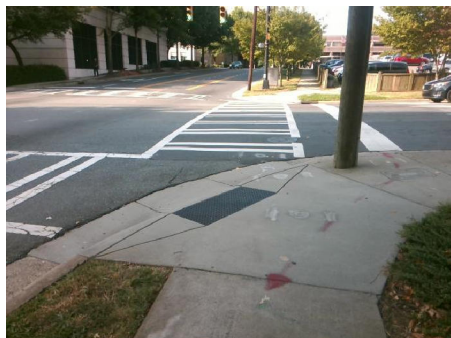
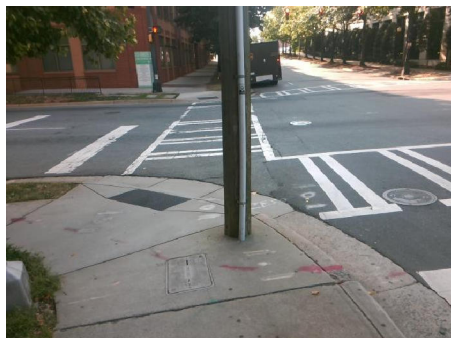
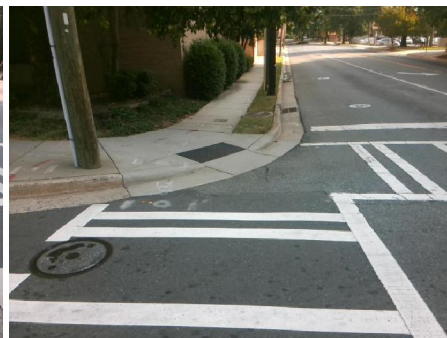
Not Found, R304.5.3

Compliance	Description	Data	Compliance	Description	Data
N/A	Ramp Length (in)	89.0	Yes	Ramp Slope (%)	7.6
Yes	Ramp Width (in)	48.0	No	Ramp XSlope (%)	7.0
N/A	Flare Type LT	N/A	N/A	Flare Type RT	N/A
N/A	Flare Slope LT (%)	N/A	N/A	Flare Slope RT (%)	N/A
N/A	Flare Traversable LT?	N/A	N/A	Flare Traversable RT?	N/A
N/A	Landing Length (in)	N/A	N/A	DWS Provided?	N/A
N/A	Landing Width (in)	N/A	N/A	DWS Contrast?	N/A
N/A	Landing Slope (%)	N/A	N/A	DWS Length (in)	N/A
N/A	Landing X Slope (%)	N/A	N/A	DWS Full Width?	N/A
N/A	Landing Curb? (Y/N)	N/A	N/A	DWS Offset (in)	N/A
N/A	Shared Landing?	N/A			
N/A	Gutter Ponding?	N/A	N/A	Gutter Slope (%)	N/A
N/A	Gutter Lip Ht (in)	N/A	N/A	Gutter X Slope (%)	N/A
N/A	Painted X Walk1?	Yes	N/A	Painted X Walk2?	Yes
	X Walk 1 Direction	To SW		X Walk 2 Direction	To SE
N/A	X Walk 1 Width (in)	104.0	N/A	X Walk 2 Width (in)	104.0
	X Walk 1 Slope (%)	9.4		X Walk 2 Slope (%)	0.2
	X Walk 1 X Slope (%)	1.0		X Walk 2 X Slope (%)	5.4

N/A	Ramp inside XWalk1?	Yes	N/A	Ramp inside XWalk2?	Yes
	Road Slope (%)	4.2	N/A	Clear Space?	N/A
	Road X Slope (%)	3.9	N/A	Clear Space to XWalk (in)	N/A
N/A	Any Obstructions?	N/A	N/A	Storm Grate/Utility Hazard?	N/A
	Obstruction Type			Storm Grate/Utility Type	
		N/A			N/A
		Yes		Surface Condition? (G/P)	Good

Remove & Replace Curb Ramp With Two New Directional Ramps or Equivalent.
